# Town of Fort Smith **Slope Monitoring Report 2025**

Slave River Adjacent to Fort Smith, NT

March 2026

CA0058096.7320

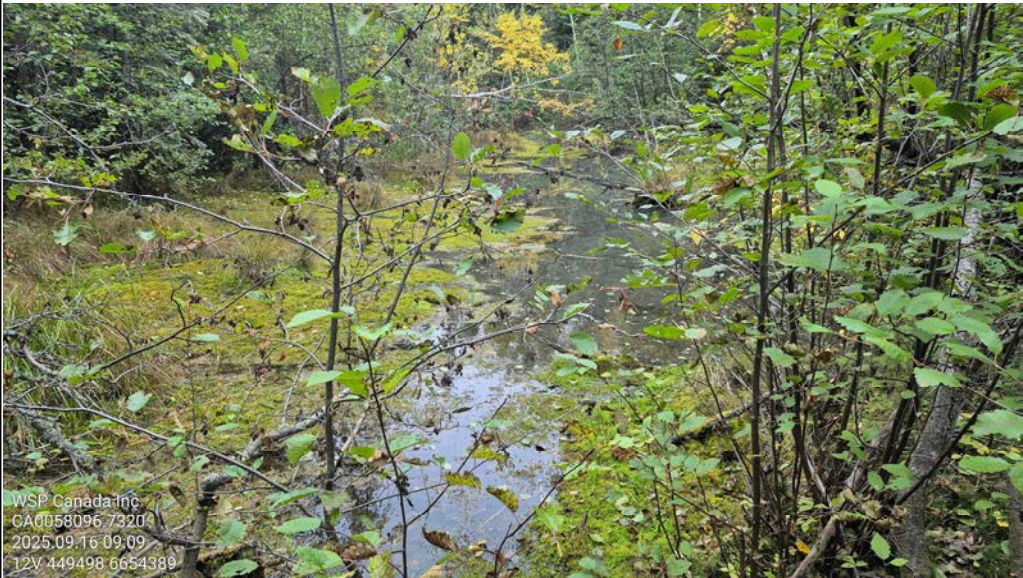
Photo 1 – area of ponded water

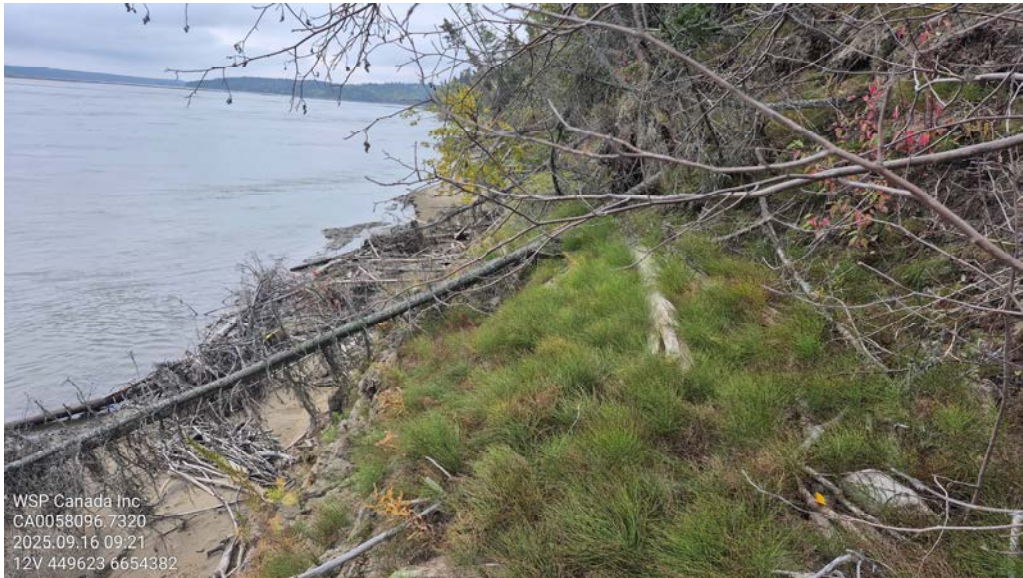
Photo 2 – erosion along toe of the slope

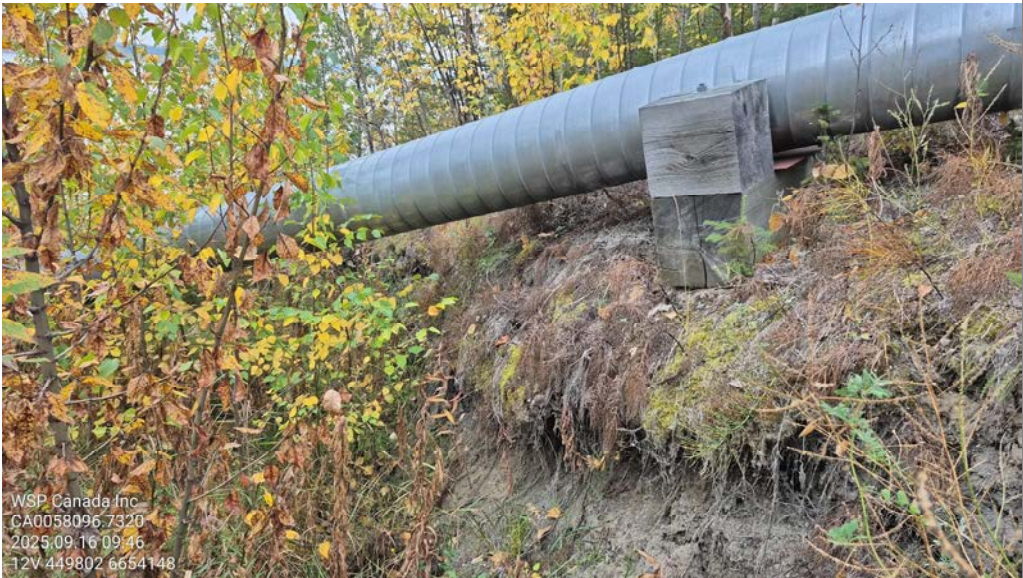
- Figure 12 – this shows the water outfall pipeline corridor from the crest of the slope down to the river. There are some sporadic areas of elevation loss and gain, including an area of ponded water on the south side of the corridor, mid-slope. The greatest changes in this area are down at the river edge, including a scarp that extended northwest, away from the pipeline between 2020 and 2025. This extended scarp was also observed in the 2022 LiDAR. This scarp under the pipeline was first observed in 2020 and is shown in 2025 on Figure 4, Photo 3, with little observable change.

Photo 3 – scarp crossing under the water outfall line, and likely impacting support pad

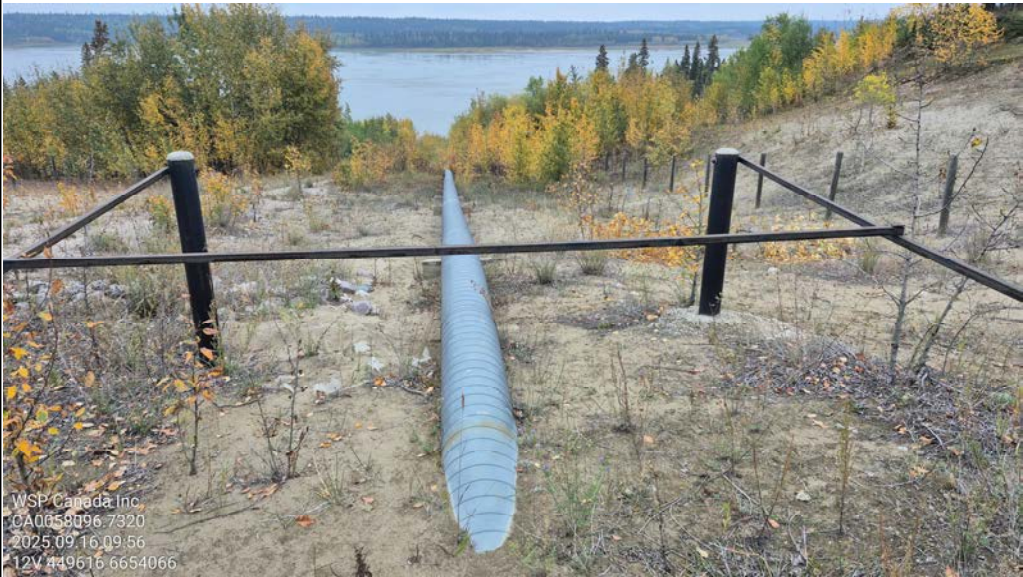
Photo 4 – water outfall pipeline near crest of slope, showing exposed sandy soil

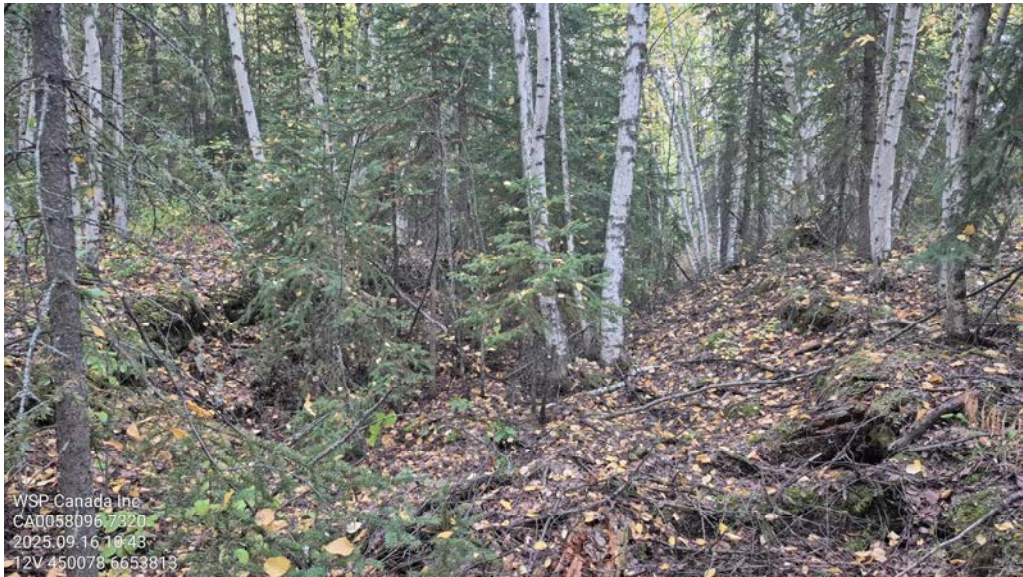
Photo 5 – lateral ground separation with legacy vegetation tears and younger trees regrowing

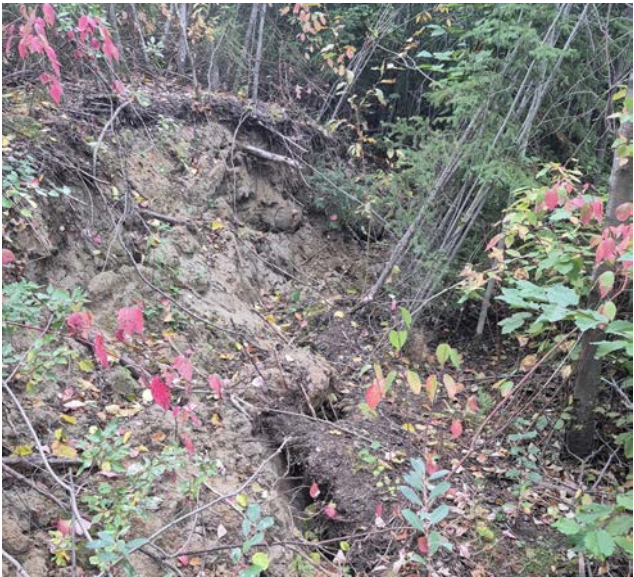
Photo 6 (cropped) – area of fresh ground movement, torn vegetation mat and tilting trees/brush

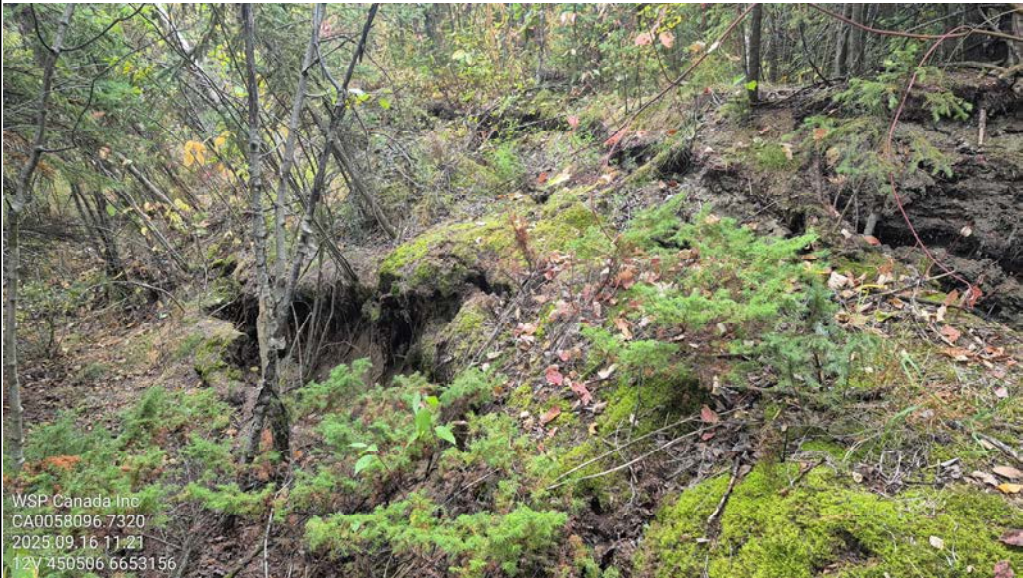
Photo 7 – parallel cracks with area of fresh ground movement, torn vegetation mat and tilting trees/brush

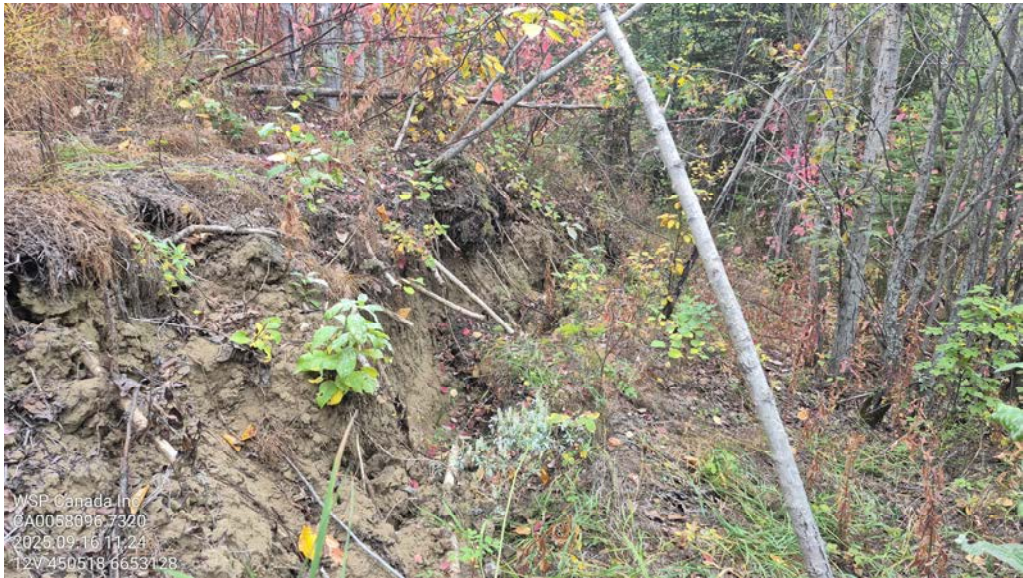
Photo 8 – area of fresh ground movement, torn vegetation mat and tilting trees/brush

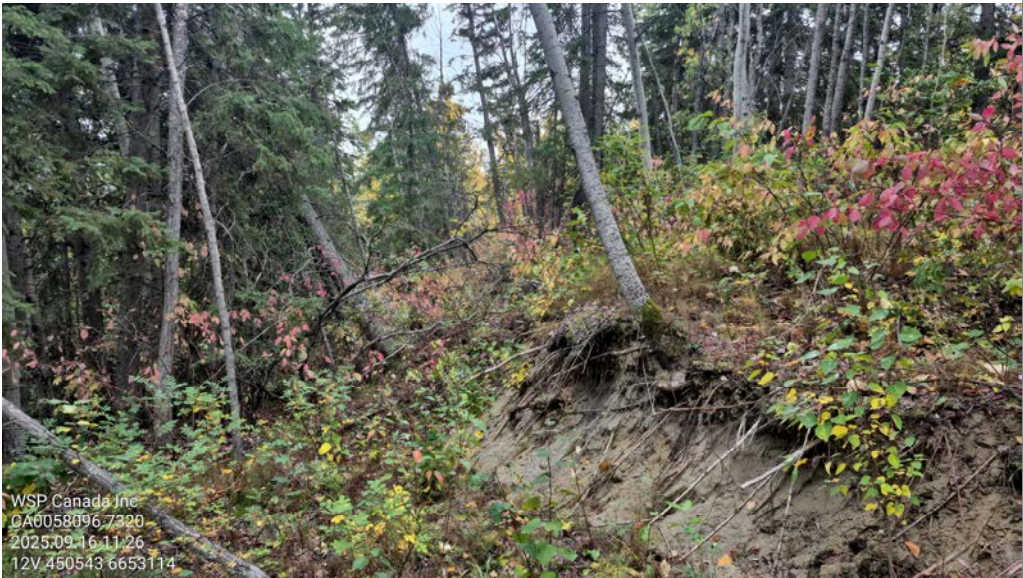
Photo 9 – area of fresh ground movement, torn vegetation mat and tilting trees/brush

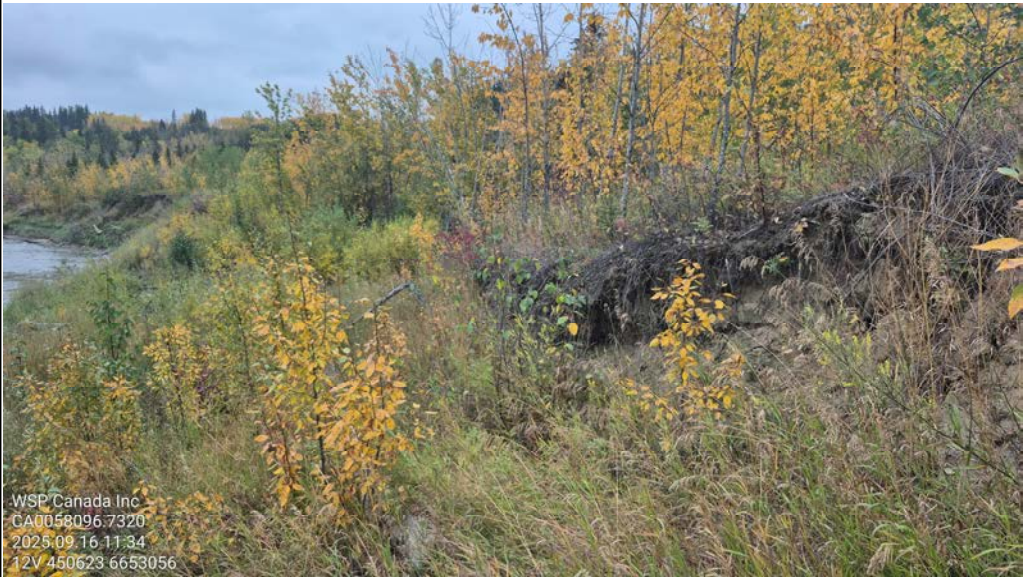
Photo 10 – scarp with exposed soil, near to the river level

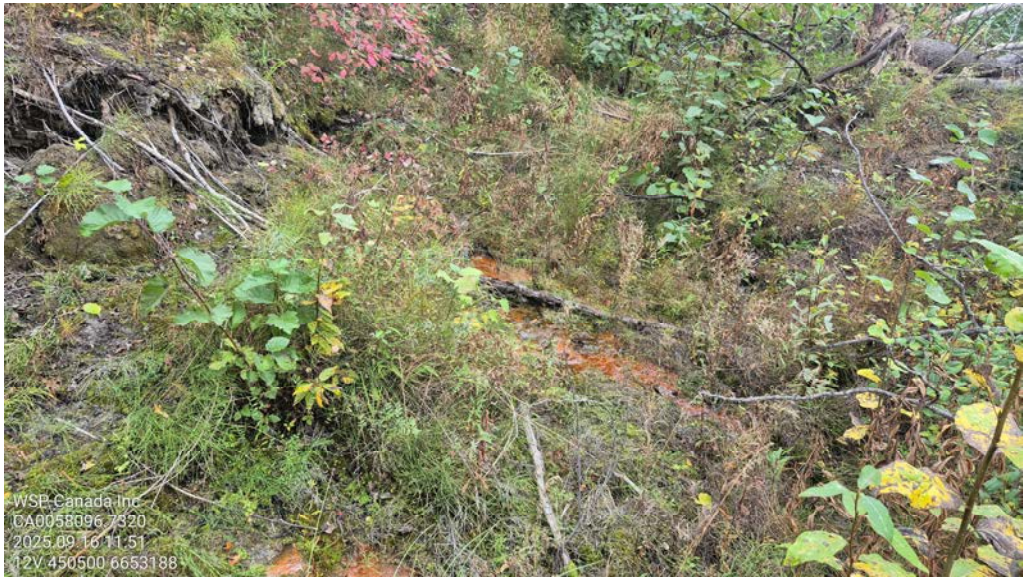
Photo 11 – water seepage from area of fresh ground cracking

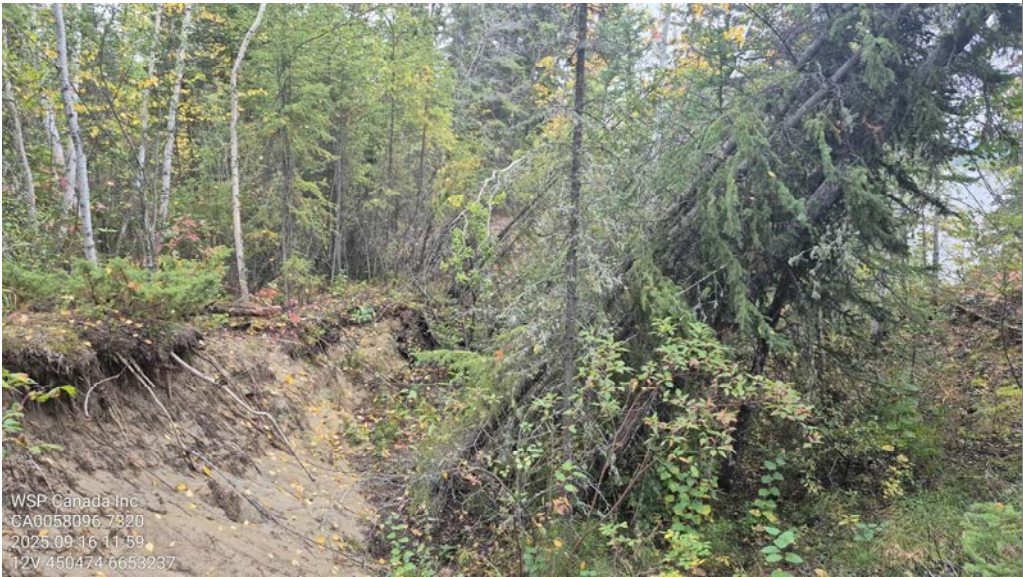
Photo 12 – scarp with exposed soil and mature tilted trees

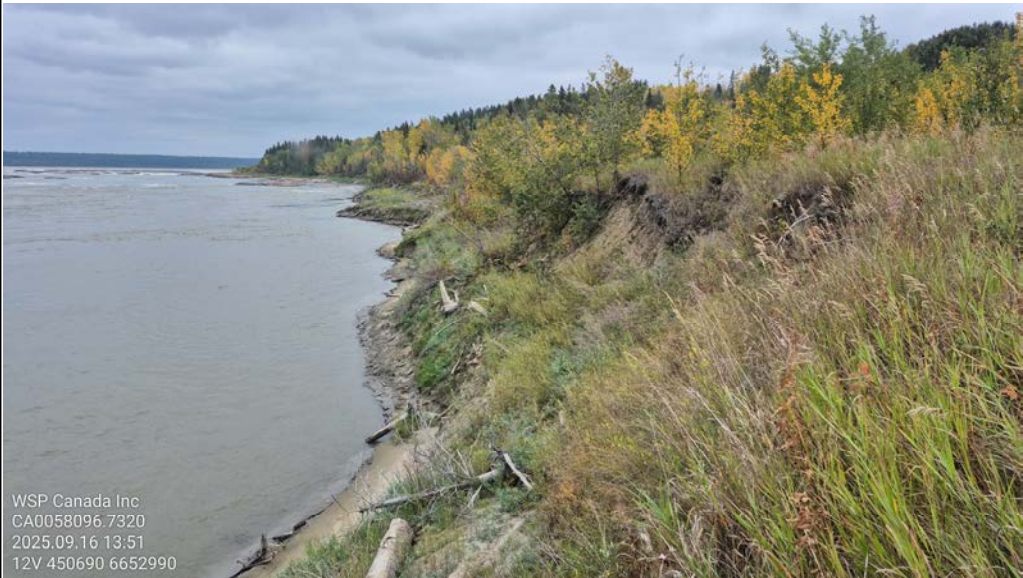
Photo 13 – scarps and benched topography along river showing erosion

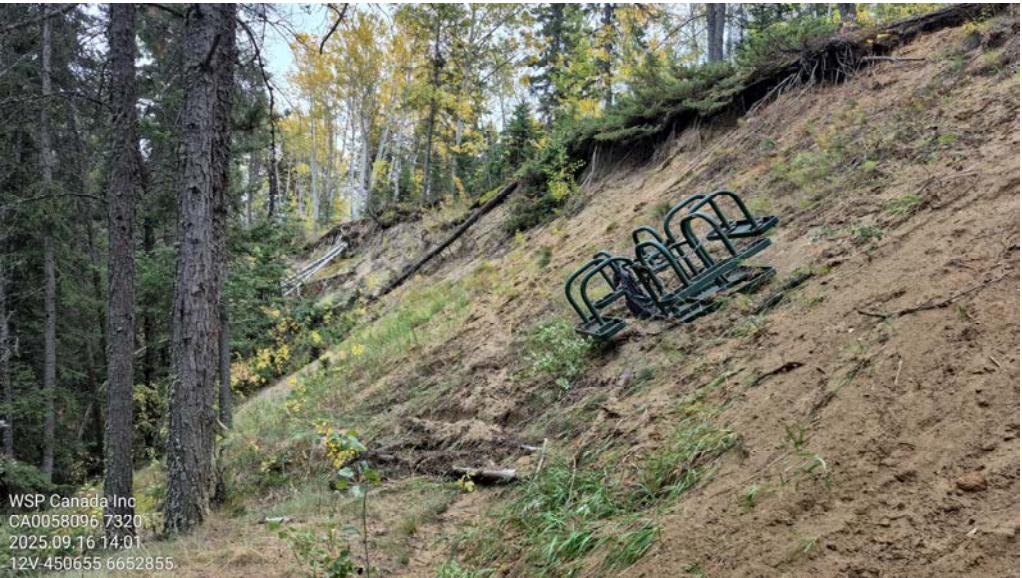
Photo 14 – headscarp, with overhanging j-trunk and fallen trees, overhanging vegetation. Vandalized picnic table in foreground.

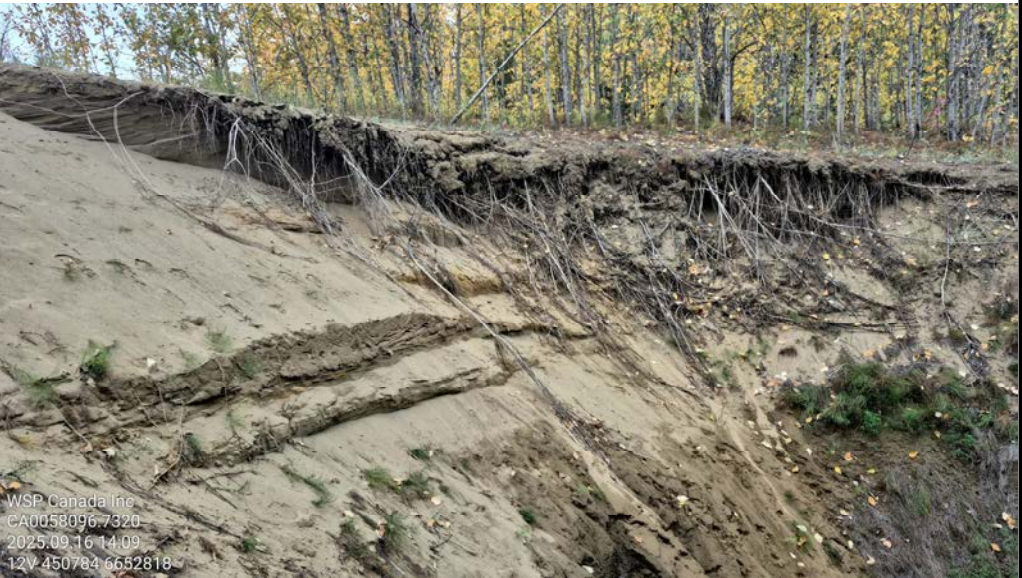
- Cemetery Area, Transect #2 – Central: on this transect, the most vertical displacement is noted in pin ID#8004 (-396 mm), which is on the downslope side of the main headscarp (Figure 10 and Figure 6, Photo 15). There was also a minor horizontal component to movement, which was toward the toe of the slope. Elevation loss in this location makes sense with landslide mechanics for large deep seated movement. Pin ID#8010, near the toe of the slope, indicates the greatest elevation displacement (drop) of -396 mm, as well as lateral movement, approximately toward the river downslope. This area (Figure 10 and Figure 6, Photo 16) appears to be experiencing erosion near the edge of the river, and localized landsliding.

Photo 15 – headscarp with overhanging vegetation. Note the moist soil on the lower right and bedded sand structure at the crest and mid-photo banding.

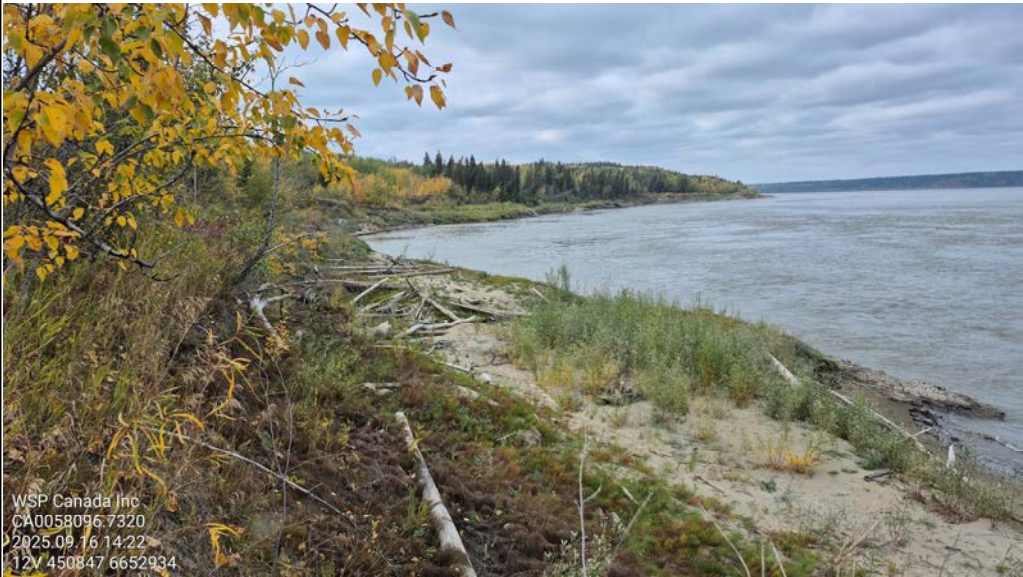
Photo 16 – toe of slope adjacent to the river showing erodible soils, high water marks, as well as tilted trees and scarps in the distance

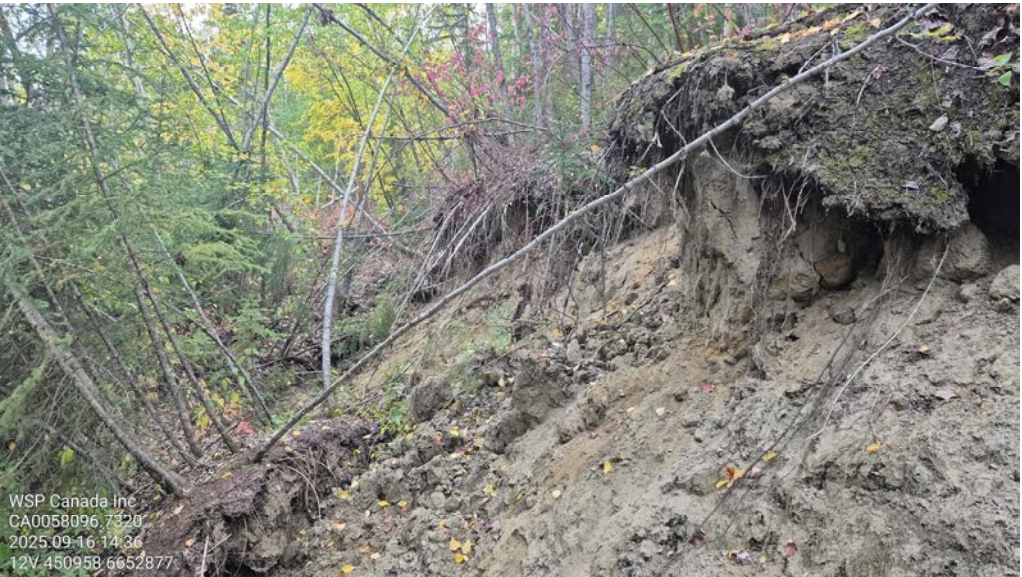
Photo 17 – scarp with mobilized vegetation mat, fore and back tilted trees

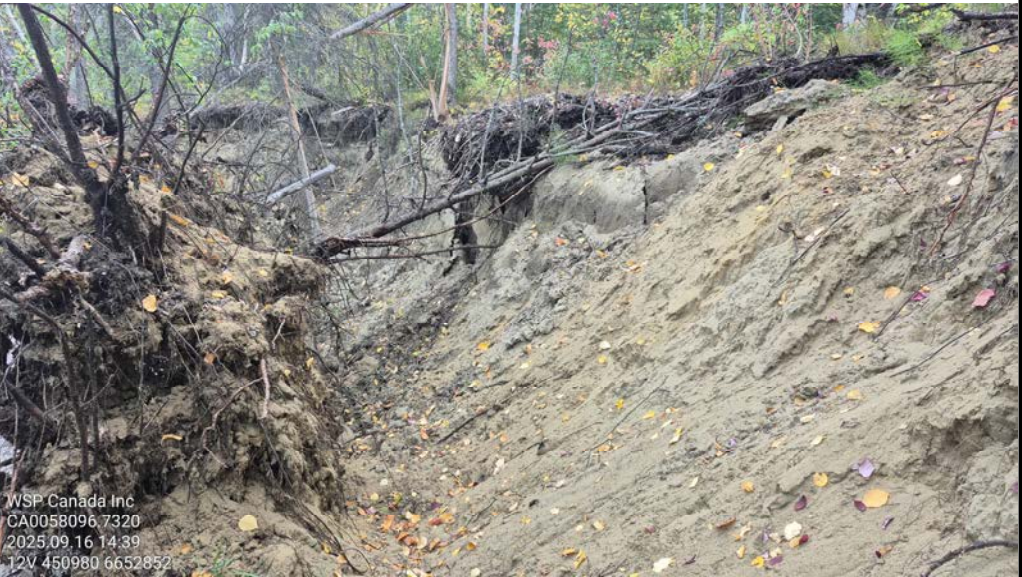
Photo 18 – scarp with exposed soil, exposed tree roots, split and damaged trees

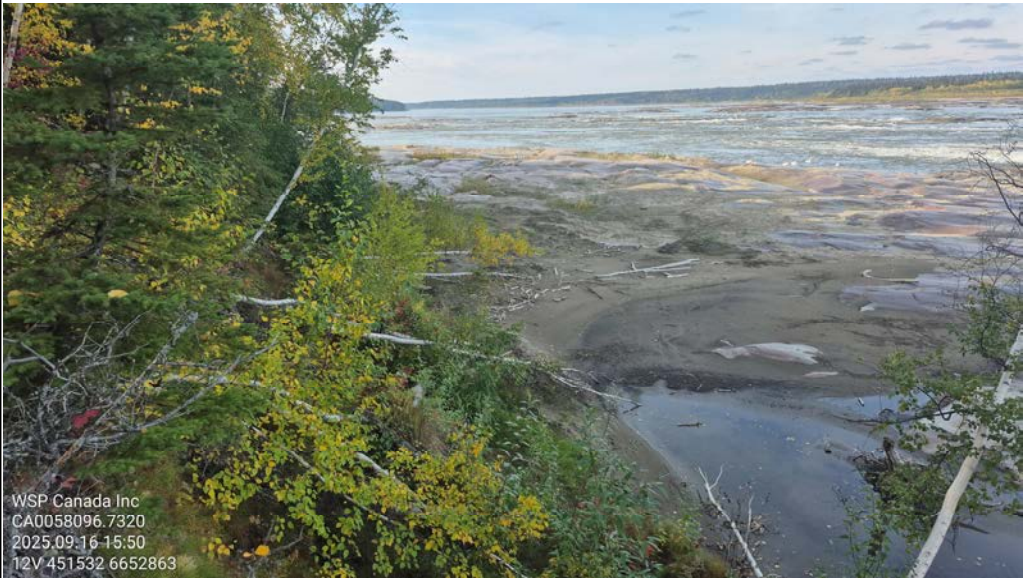
Photo 19 – fallen and tilting trees near river. Note exposed granite bedrock surface exposed adjacent to flowing river

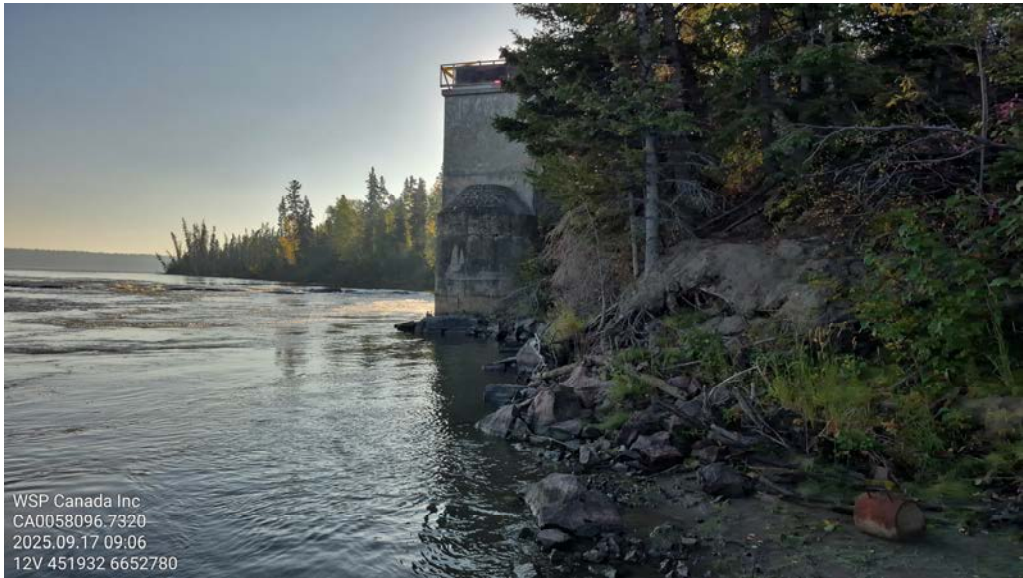
Photo 20 – water intake area. Note exposed suspected bedrock foundation and highwater mark

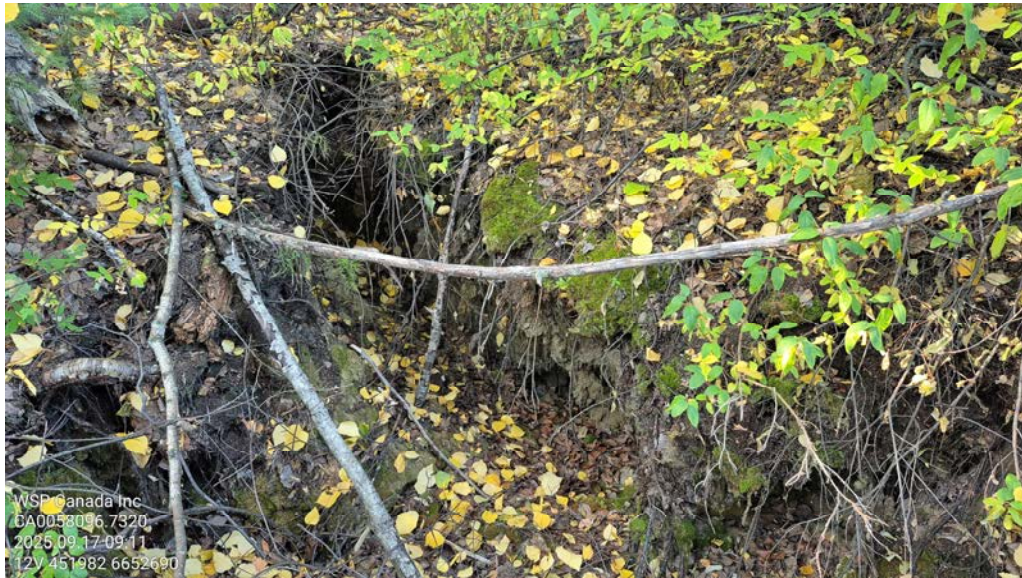
Photo 21 – vegetation mat tears, possibly indicative of ground movement.

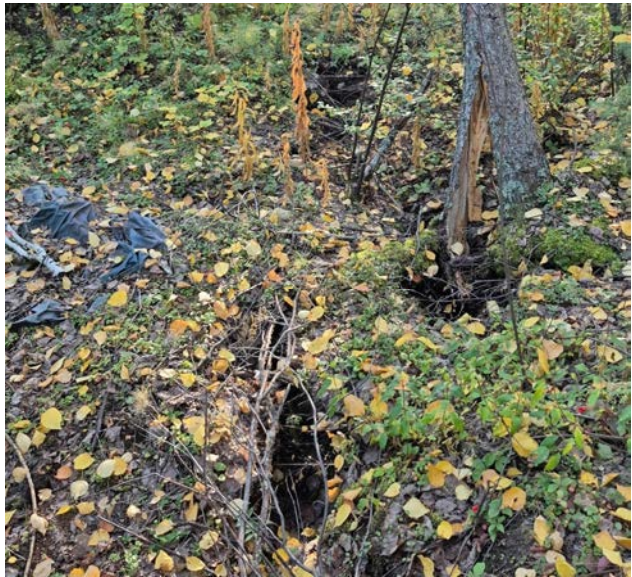
Photo 22 (cropped) – consecutive vegetation mat tears aligned with split tree trunk

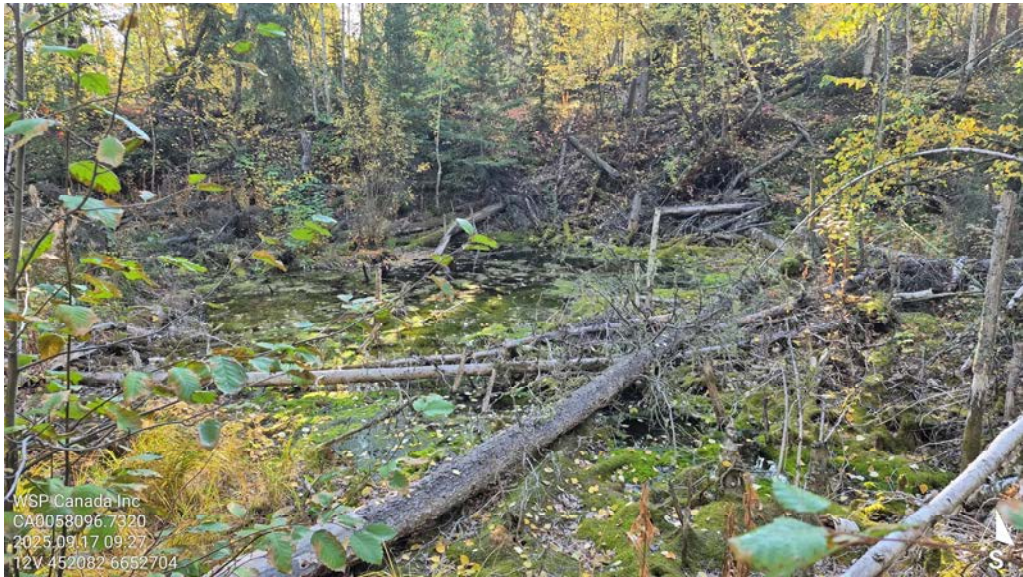
Photo 23 – area of ponded water on slope

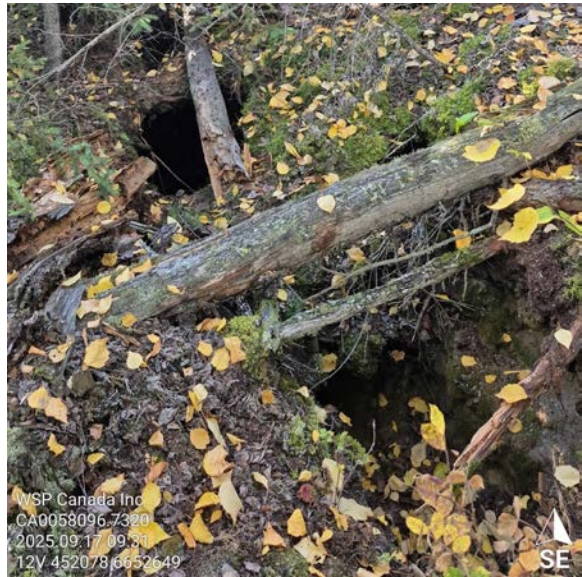
Photo 24 (cropped) – continuous vegetation tear and open void beneath

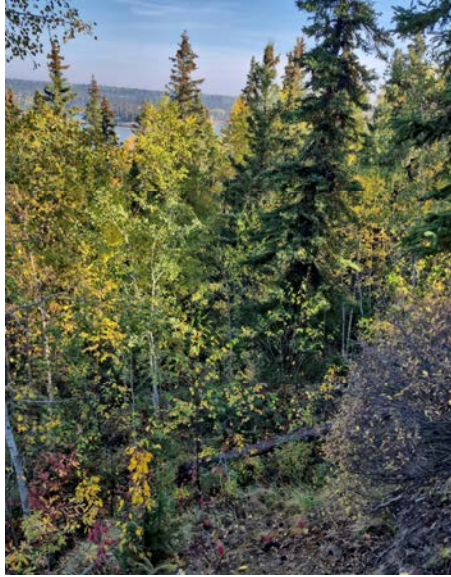
Photo 25 – headscarp area, showing relatively straight trees below

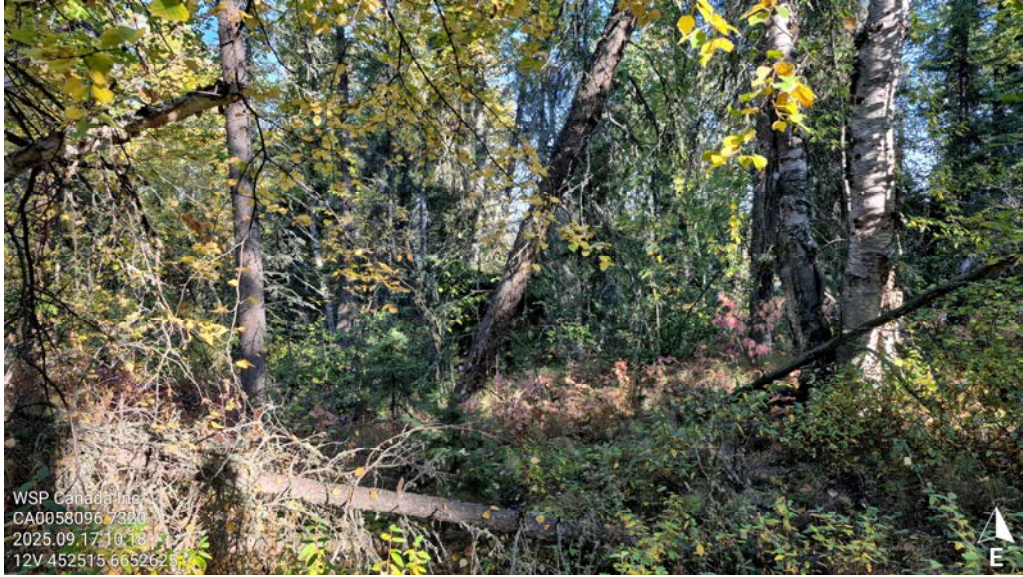
Photo 26 – area of relative stability, with some tilted trees

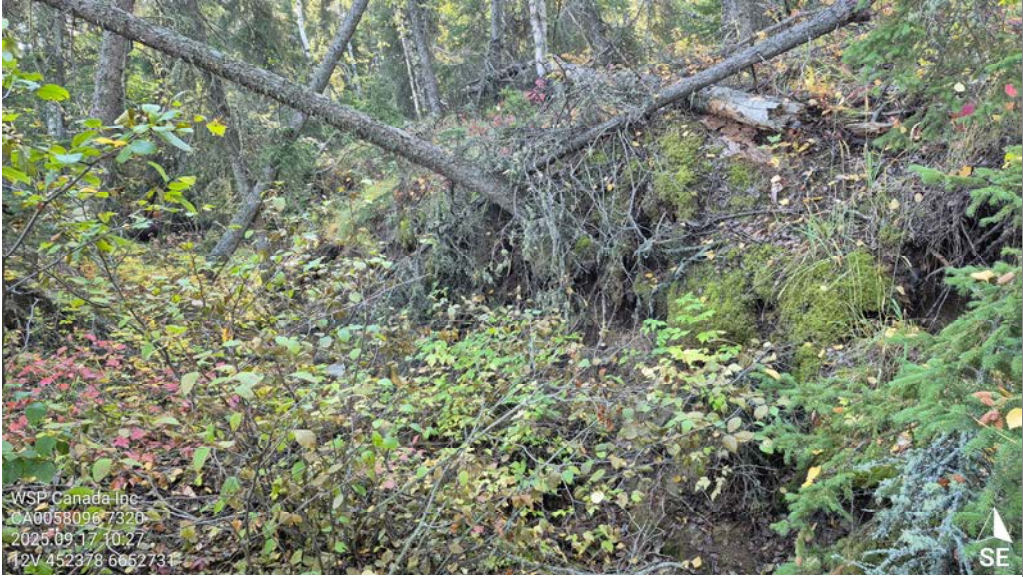
Photo 27 – scarp with fore and back tilted trees, some exposed soil

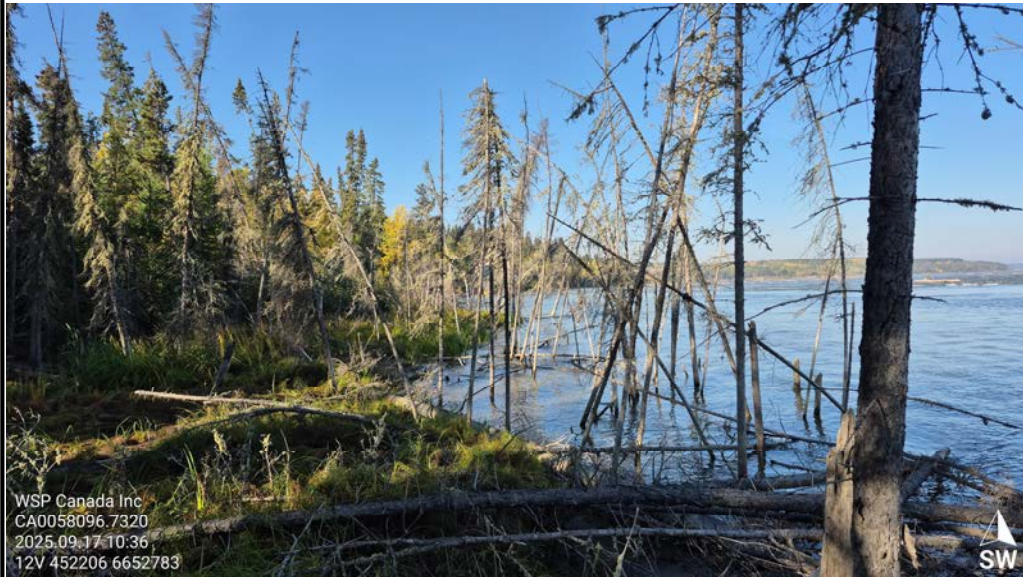
Photo 28 – toe of slope adjacent to the river showing eroding bank and flooded trees

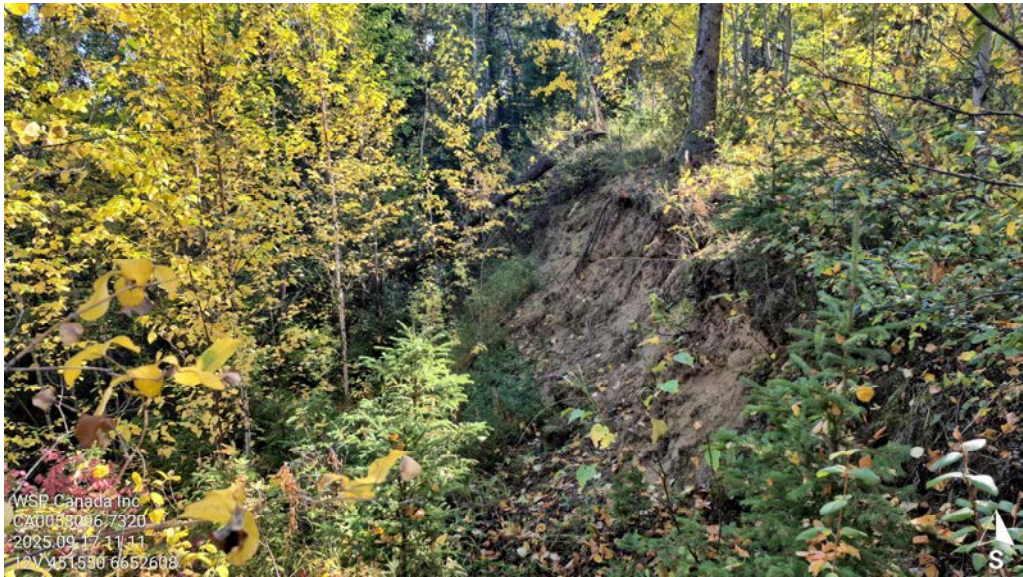
Photo 29 – headscarp with exposed soil

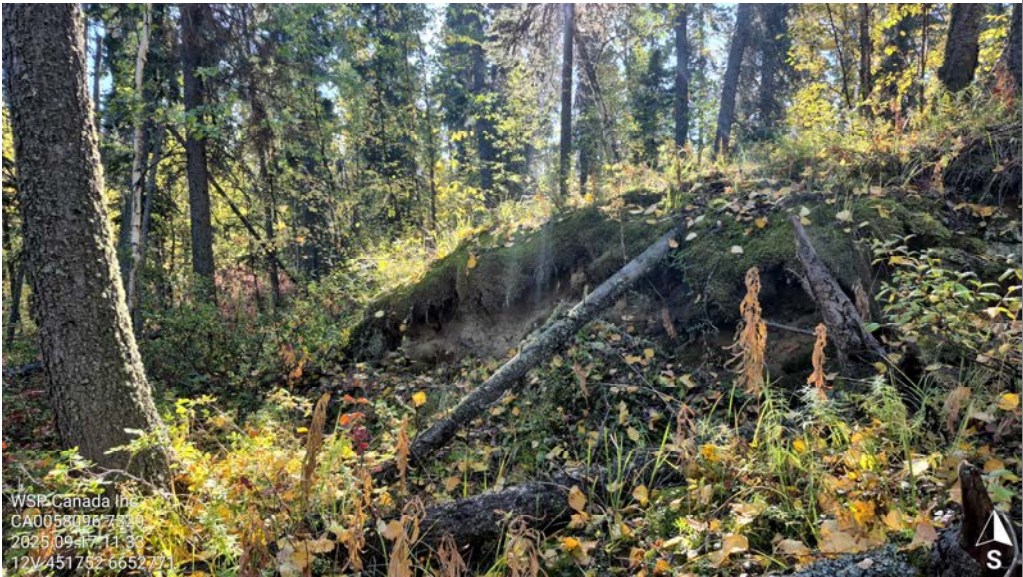
Photo 30 – scarp with exposed soil

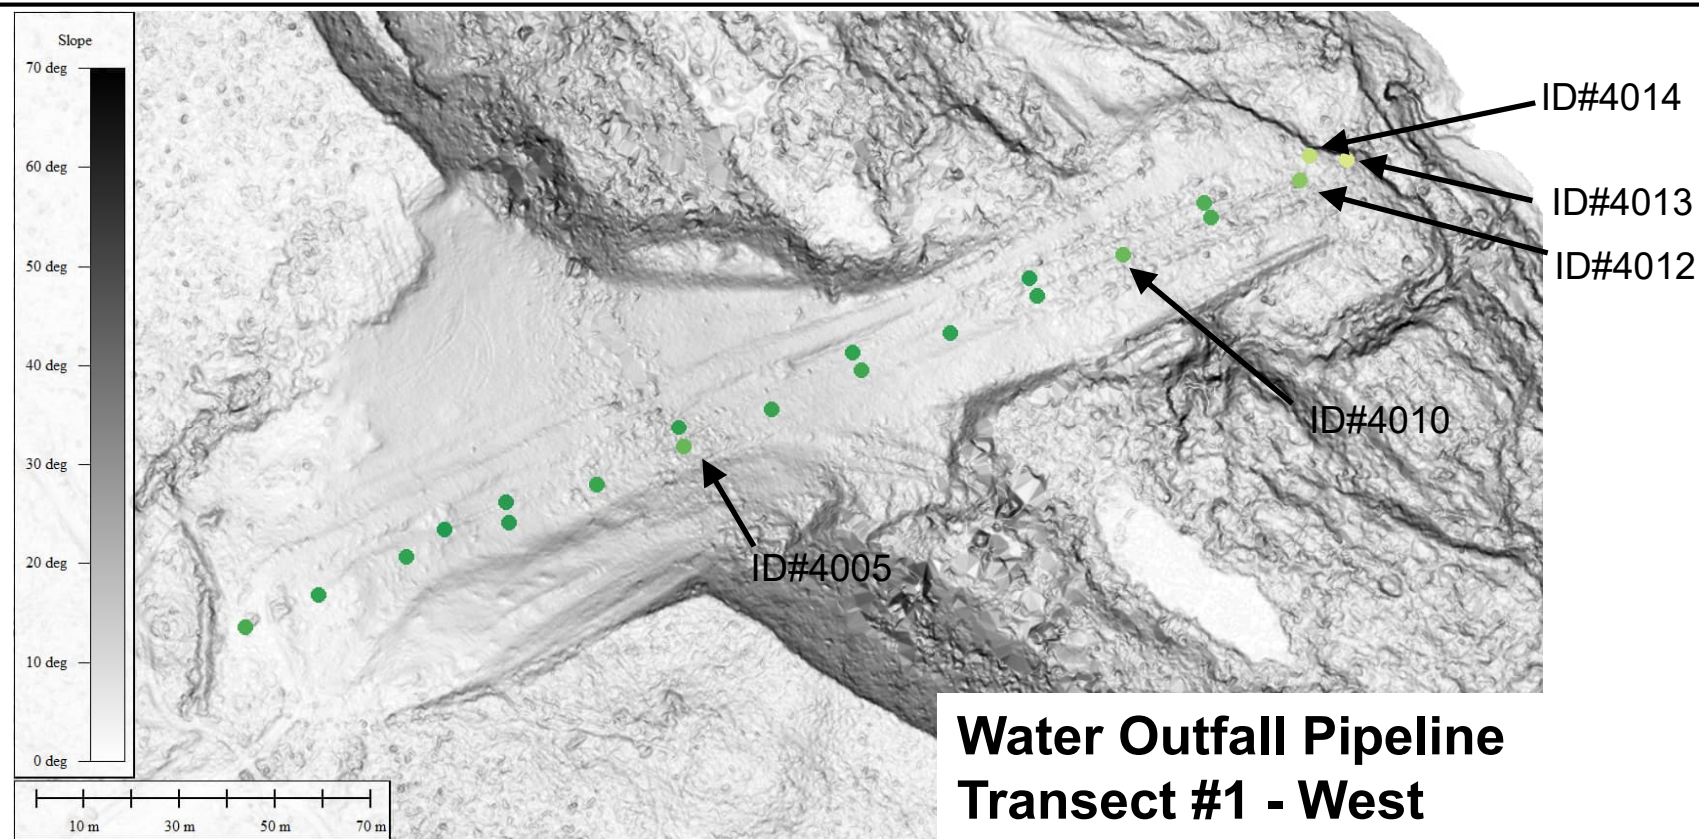
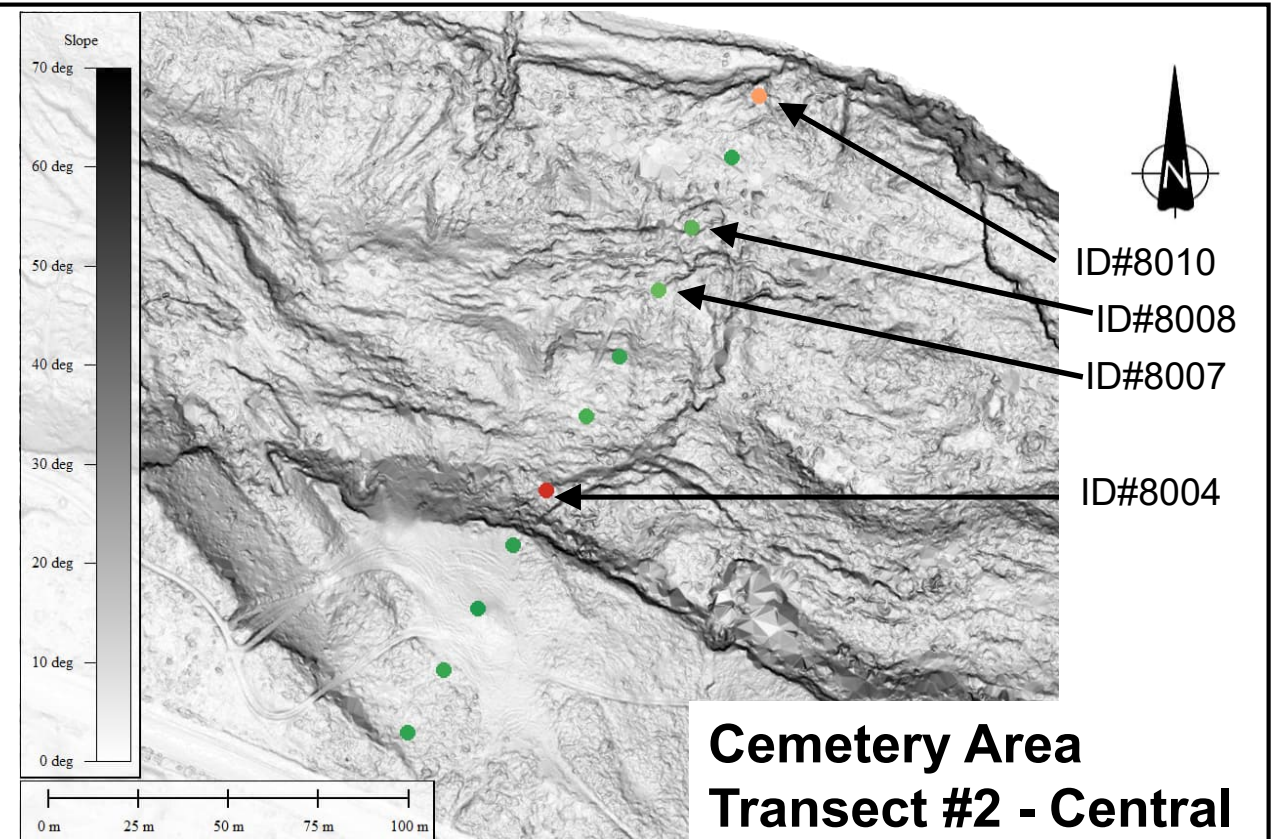
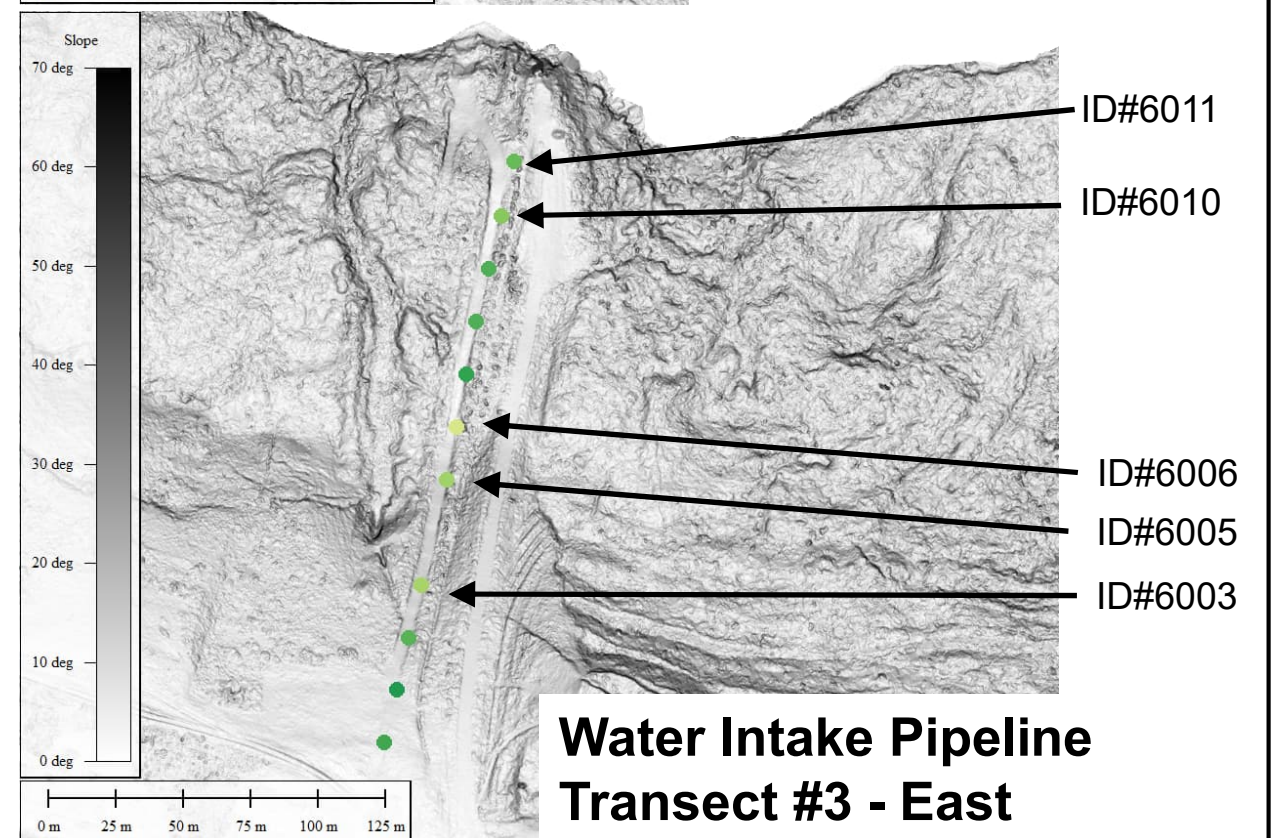
- Water Outfall Pipeline, Transect #1 – West: on this transect, the most measured vertical displacement was -158 mm and the most measured horizontal displacement was 142 mm, both for pin ID#4013. The horizontal displacement was in the downslope direction. This pin is near the toe of the slope, in the area where a large crack can be seen on the LiDAR (Figure 10) and is shown on Figure 4, Photo 3. All three pins in this area (ID#4012, 4013, 4014) indicate elevation displacement (drop) since the 2022 survey.

- Water Intake Pipeline, Transect #3 – East: on this transect, the most measured vertical displacement was -151 mm and the most measured horizontal displacement was 132 mm, both for pin ID#6006. The horizontal displacement was in the downslope direction. This location is also on the downslope side of the main headscarp, although this area has been regraded for the waterline. Elevation loss and the movement direction in this location makes sense with landslide mechanics for large deep seated movement. Pin ID#6005 and Pin ID#6003 are also in this headscarp area, abet upslope and also indicate similar direction and elevation loss displacements. Pin ID#6004 was reported as “disturbed” by the survey contractor, additional information on this pin in 2026 may provide more context. Most pins along this transect indicate movement in the downslope direction, toward the river. No significant field observations were noted along this transect.
