# Town of Fort Smith **Slope Monitoring Report 2025**

Slave River Adjacent to Fort Smith, NT

March 2026

CA0058096.7320

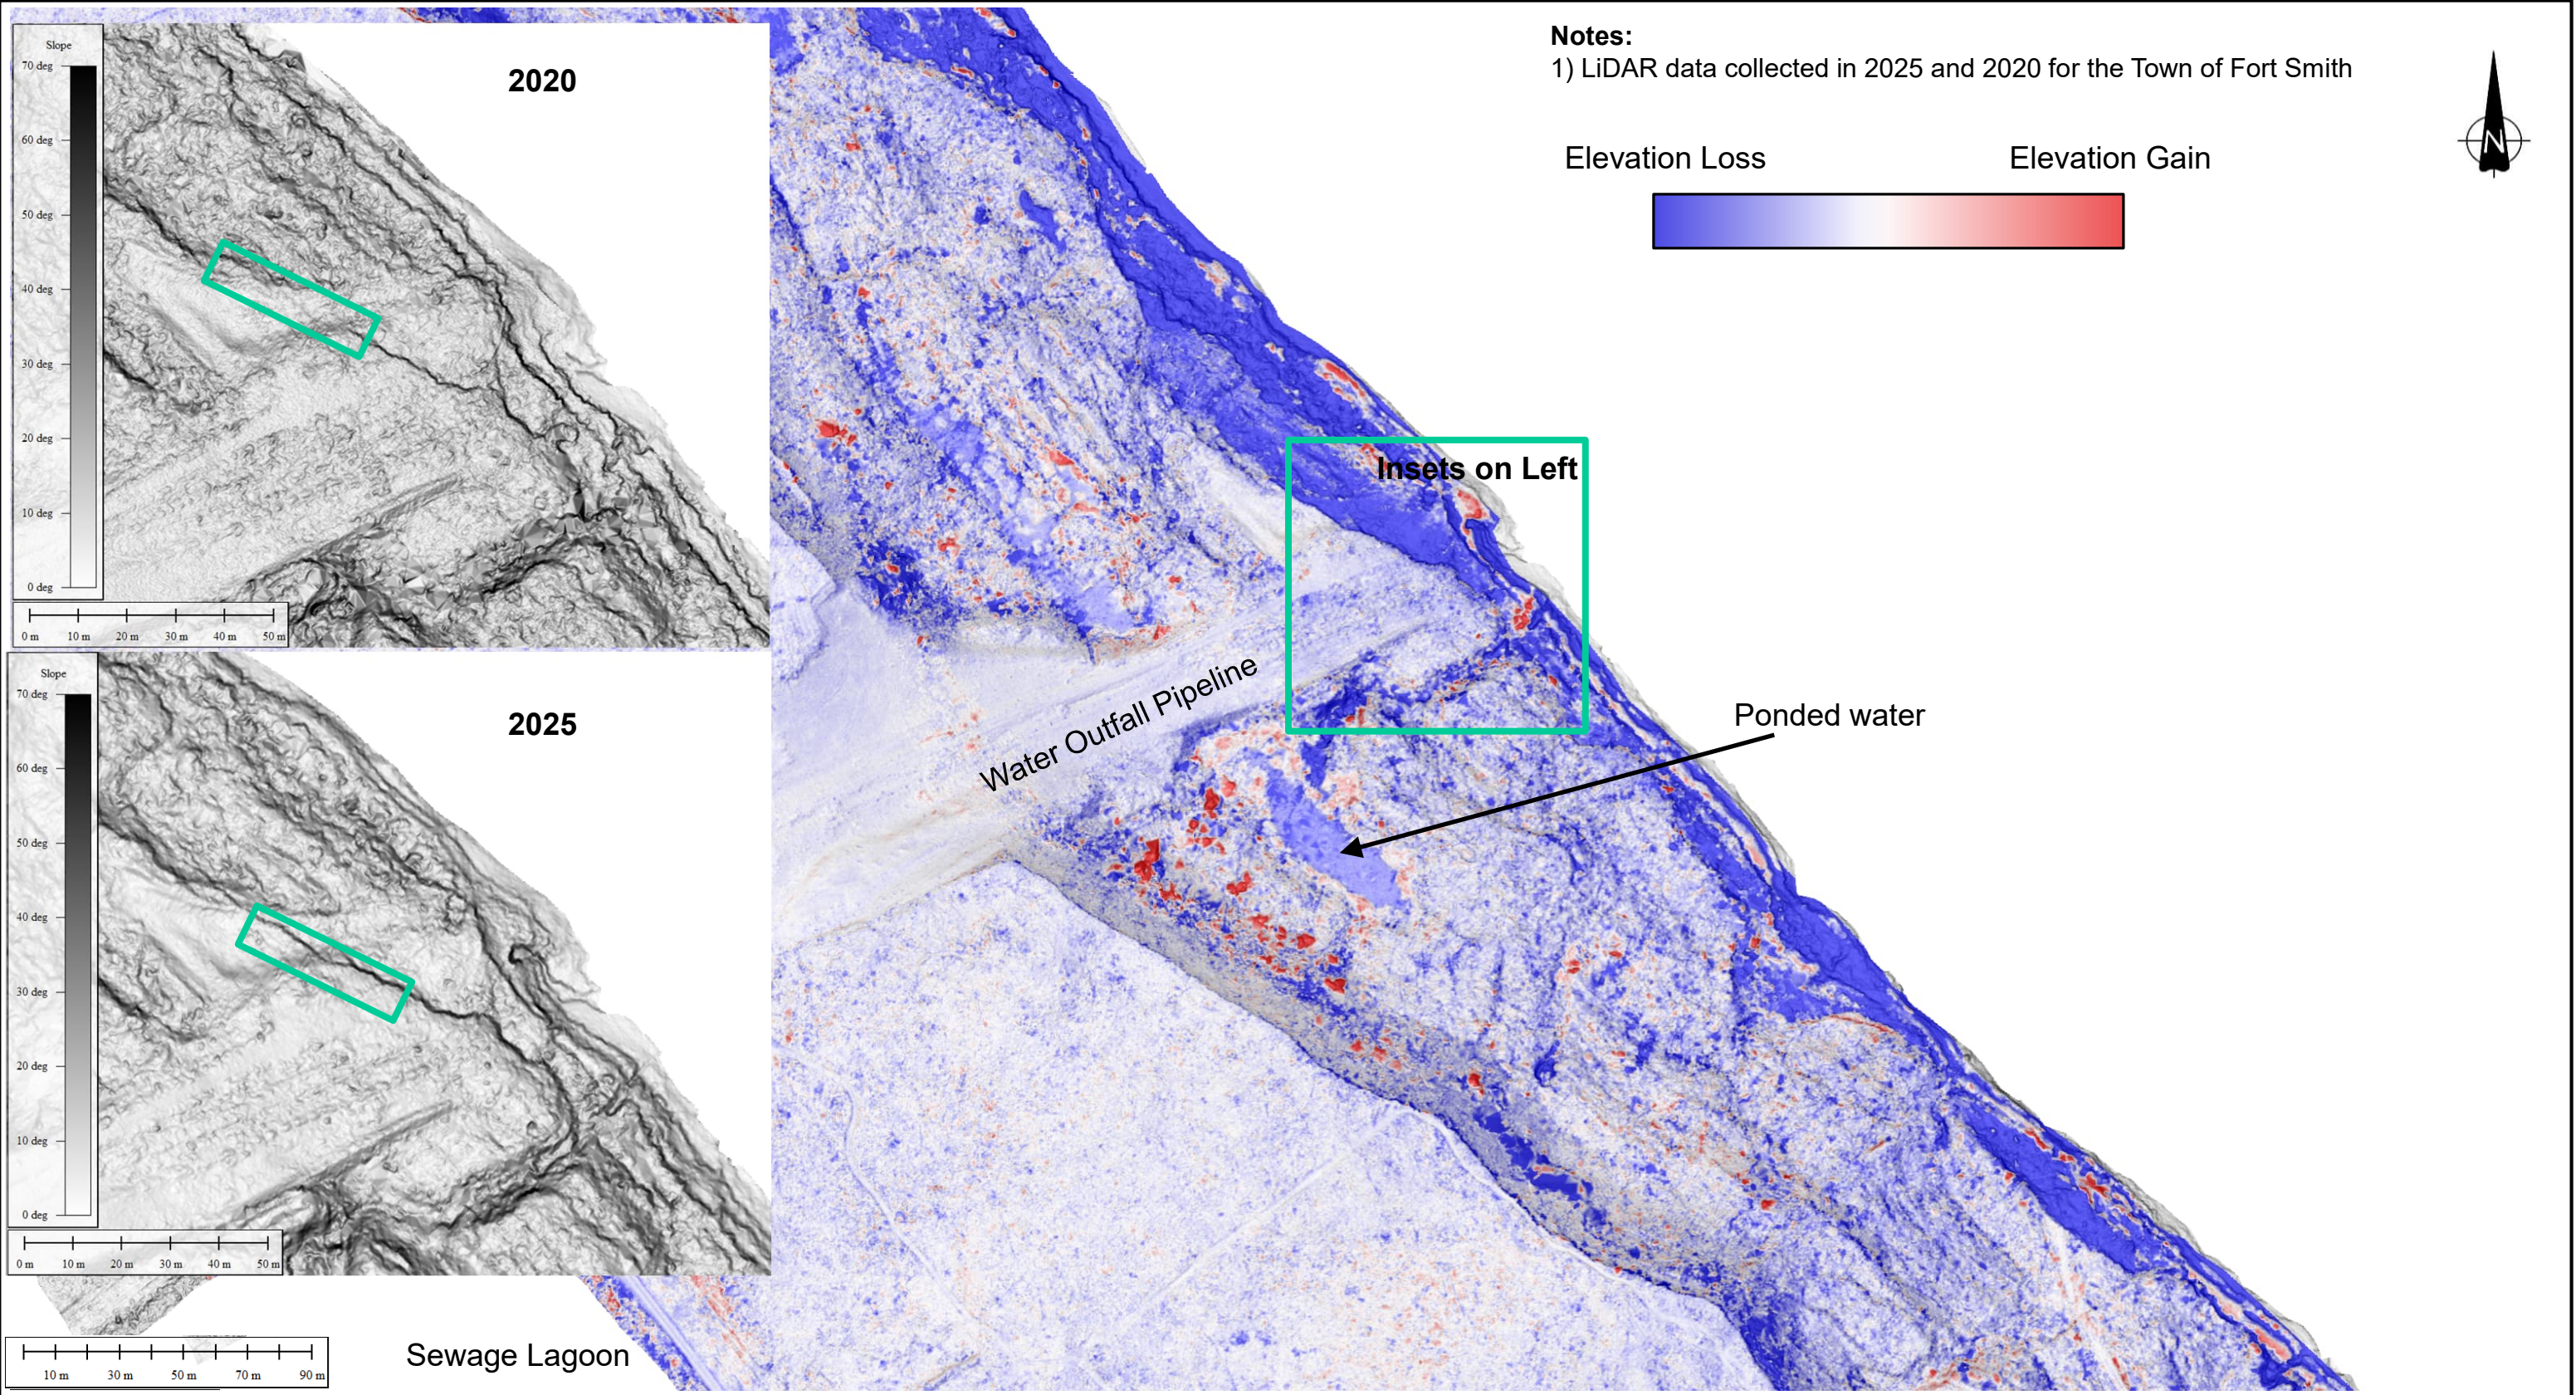
- Figure 12 – this shows the water outfall pipeline corridor from the crest of the slope down to the river. There are some sporadic areas of elevation loss and gain, including an area of ponded water on the south side of the corridor, mid-slope. The greatest changes in this area are down at the river edge, including a scarp that extended northwest, away from the pipeline between 2020 and 2025. This extended scarp was also observed in the 2022 LiDAR. This scarp under the pipeline was first observed in 2020 and is shown in 2025 on Figure 4, Photo 3, with little observable change.

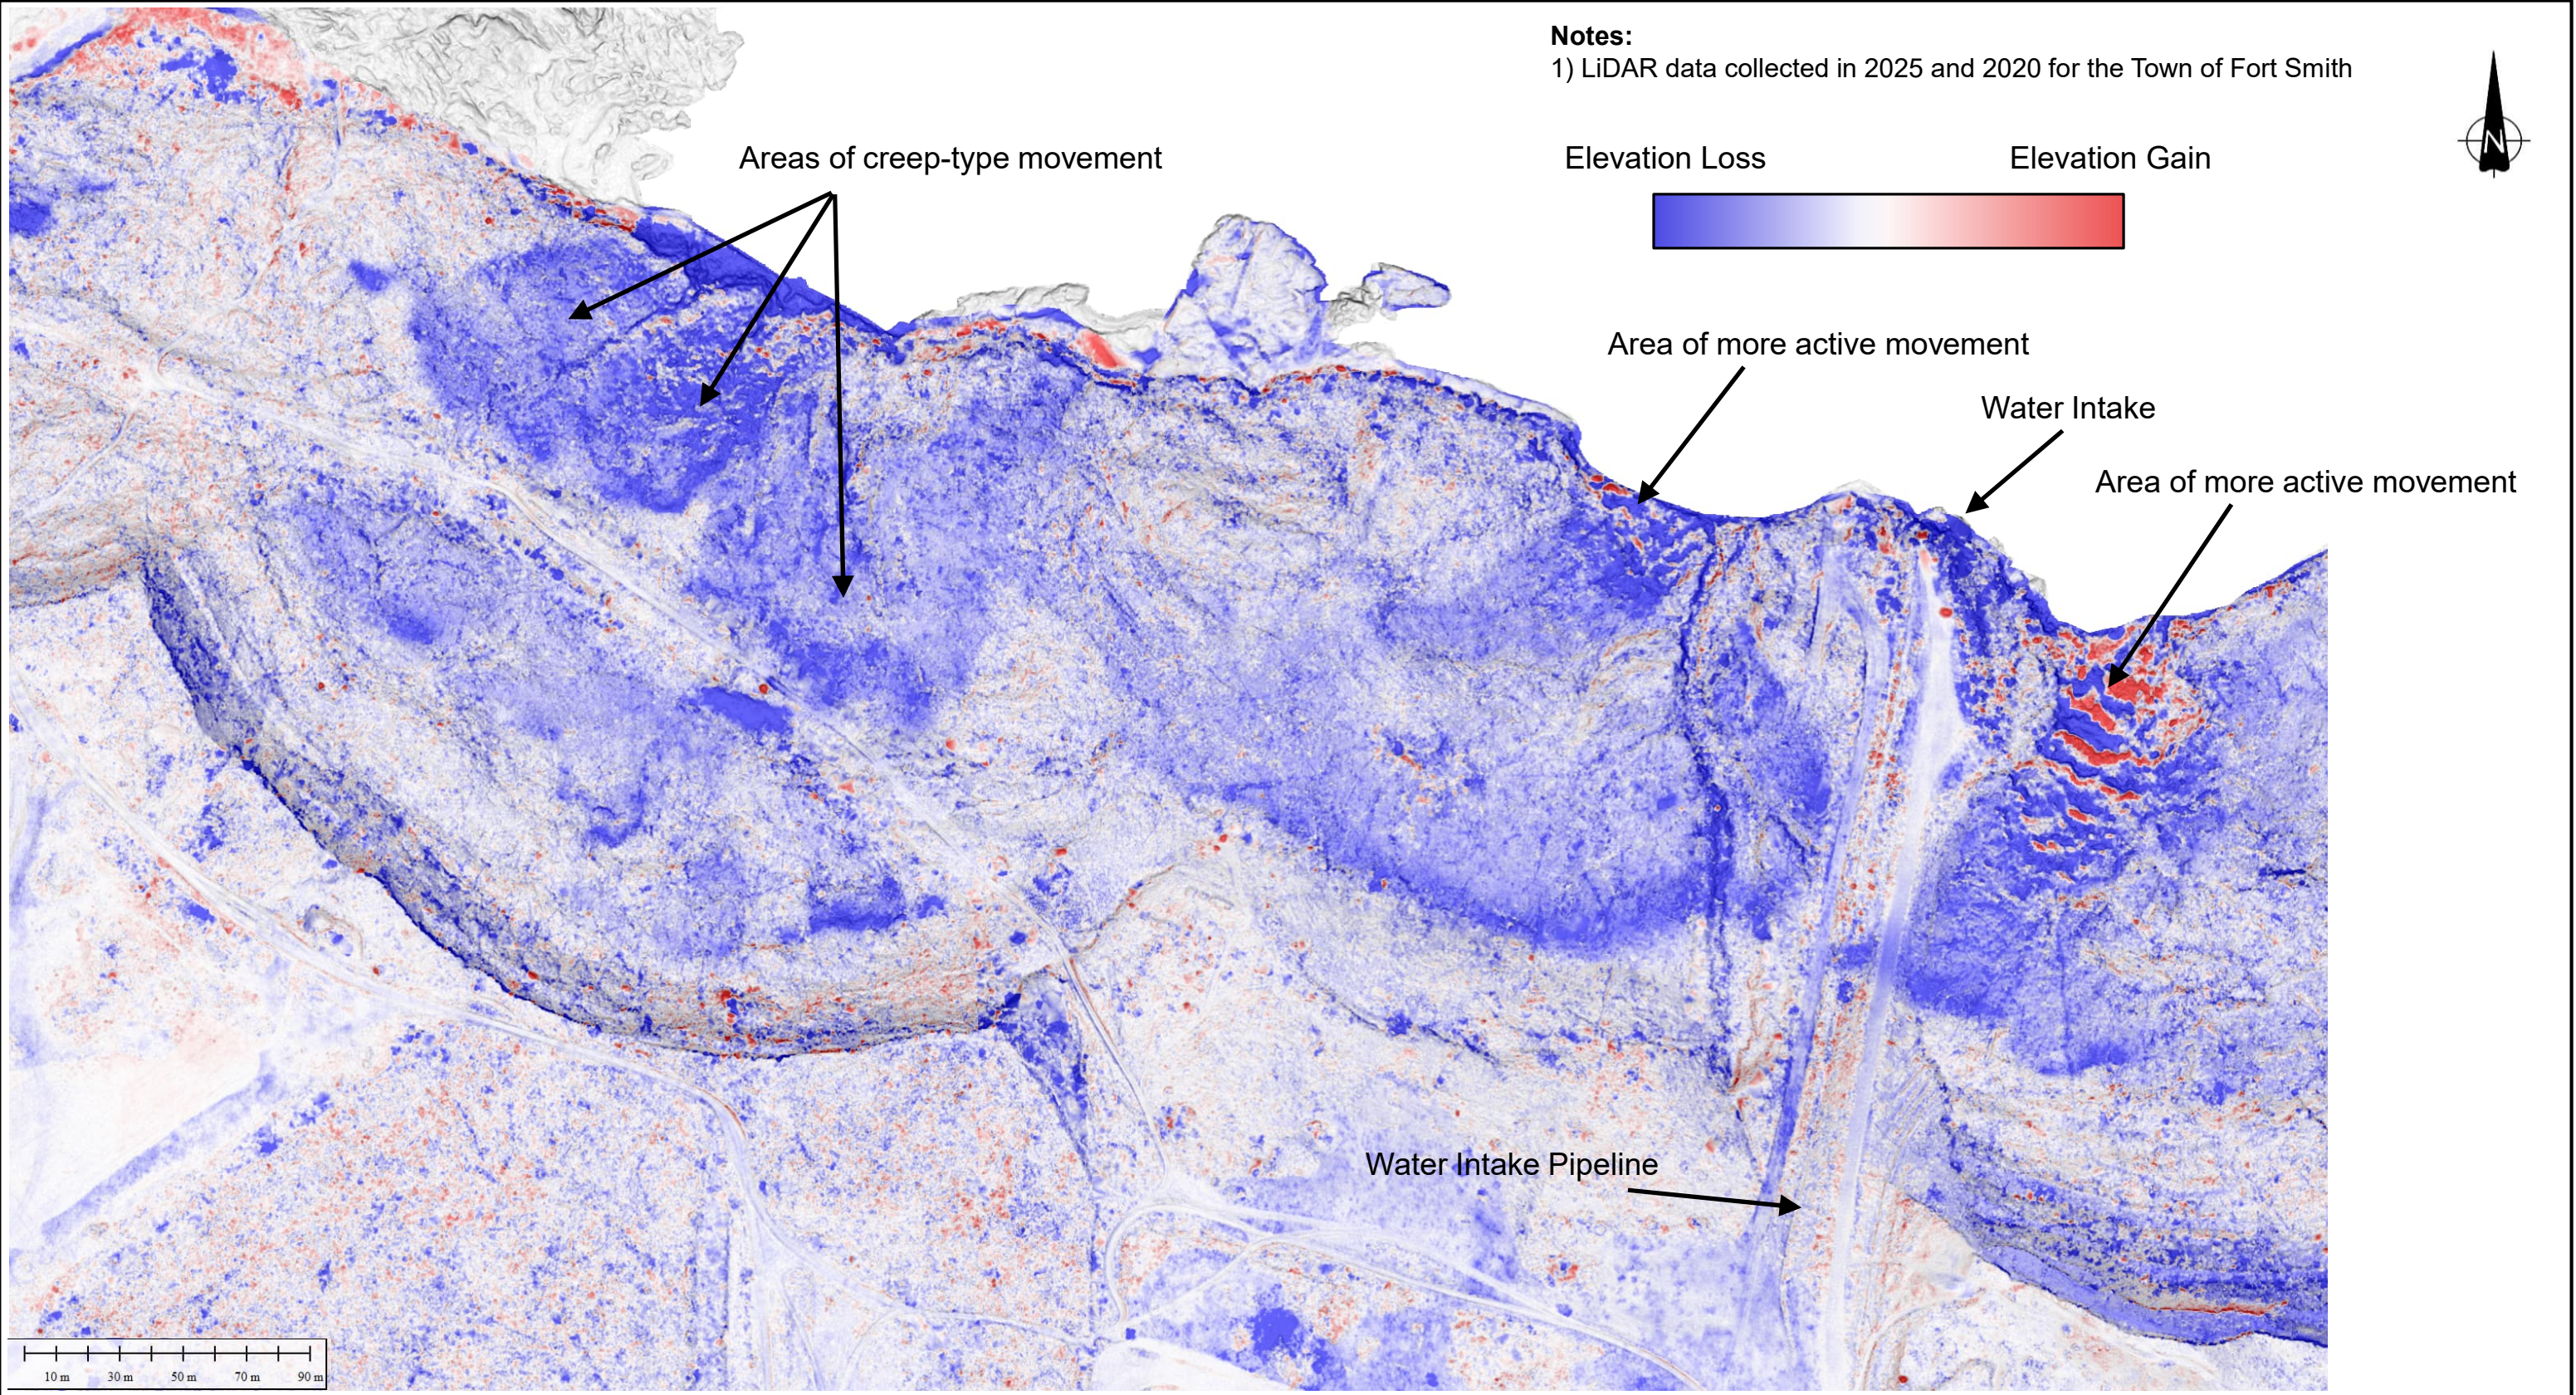
- Figure 14 – this shows several areas of apparent creep toward the river as evidenced by areas of broad elevation loss (i.e., blue) and indicated on the figure. In many cases these areas are in close proximity to drainage features and/or seepage areas. Creep-type movement may be deep seated or relatively shallow and related to seasonal freeze-thaw cycles. The upper extent of this apparent creep in many cases is around elevation 190 m, which is about 1/3 up the slope. It is possible this corresponds with a stratigraphic feature or melting permafrost. Two areas of more active movement as indicated by the LCD are immediately upstream and downstream of the water intake structure. Photographs of these areas from the visual slope inspection are presented on Figure 7. The area of more active movement on the upstream side of the water intake location also shows change in the 2022 to 2025 LCD.
