# Town of Fort Smith **Slope Monitoring Report 2025**

Slave River Adjacent to Fort Smith, NT

March 2026

CA0058096.7320

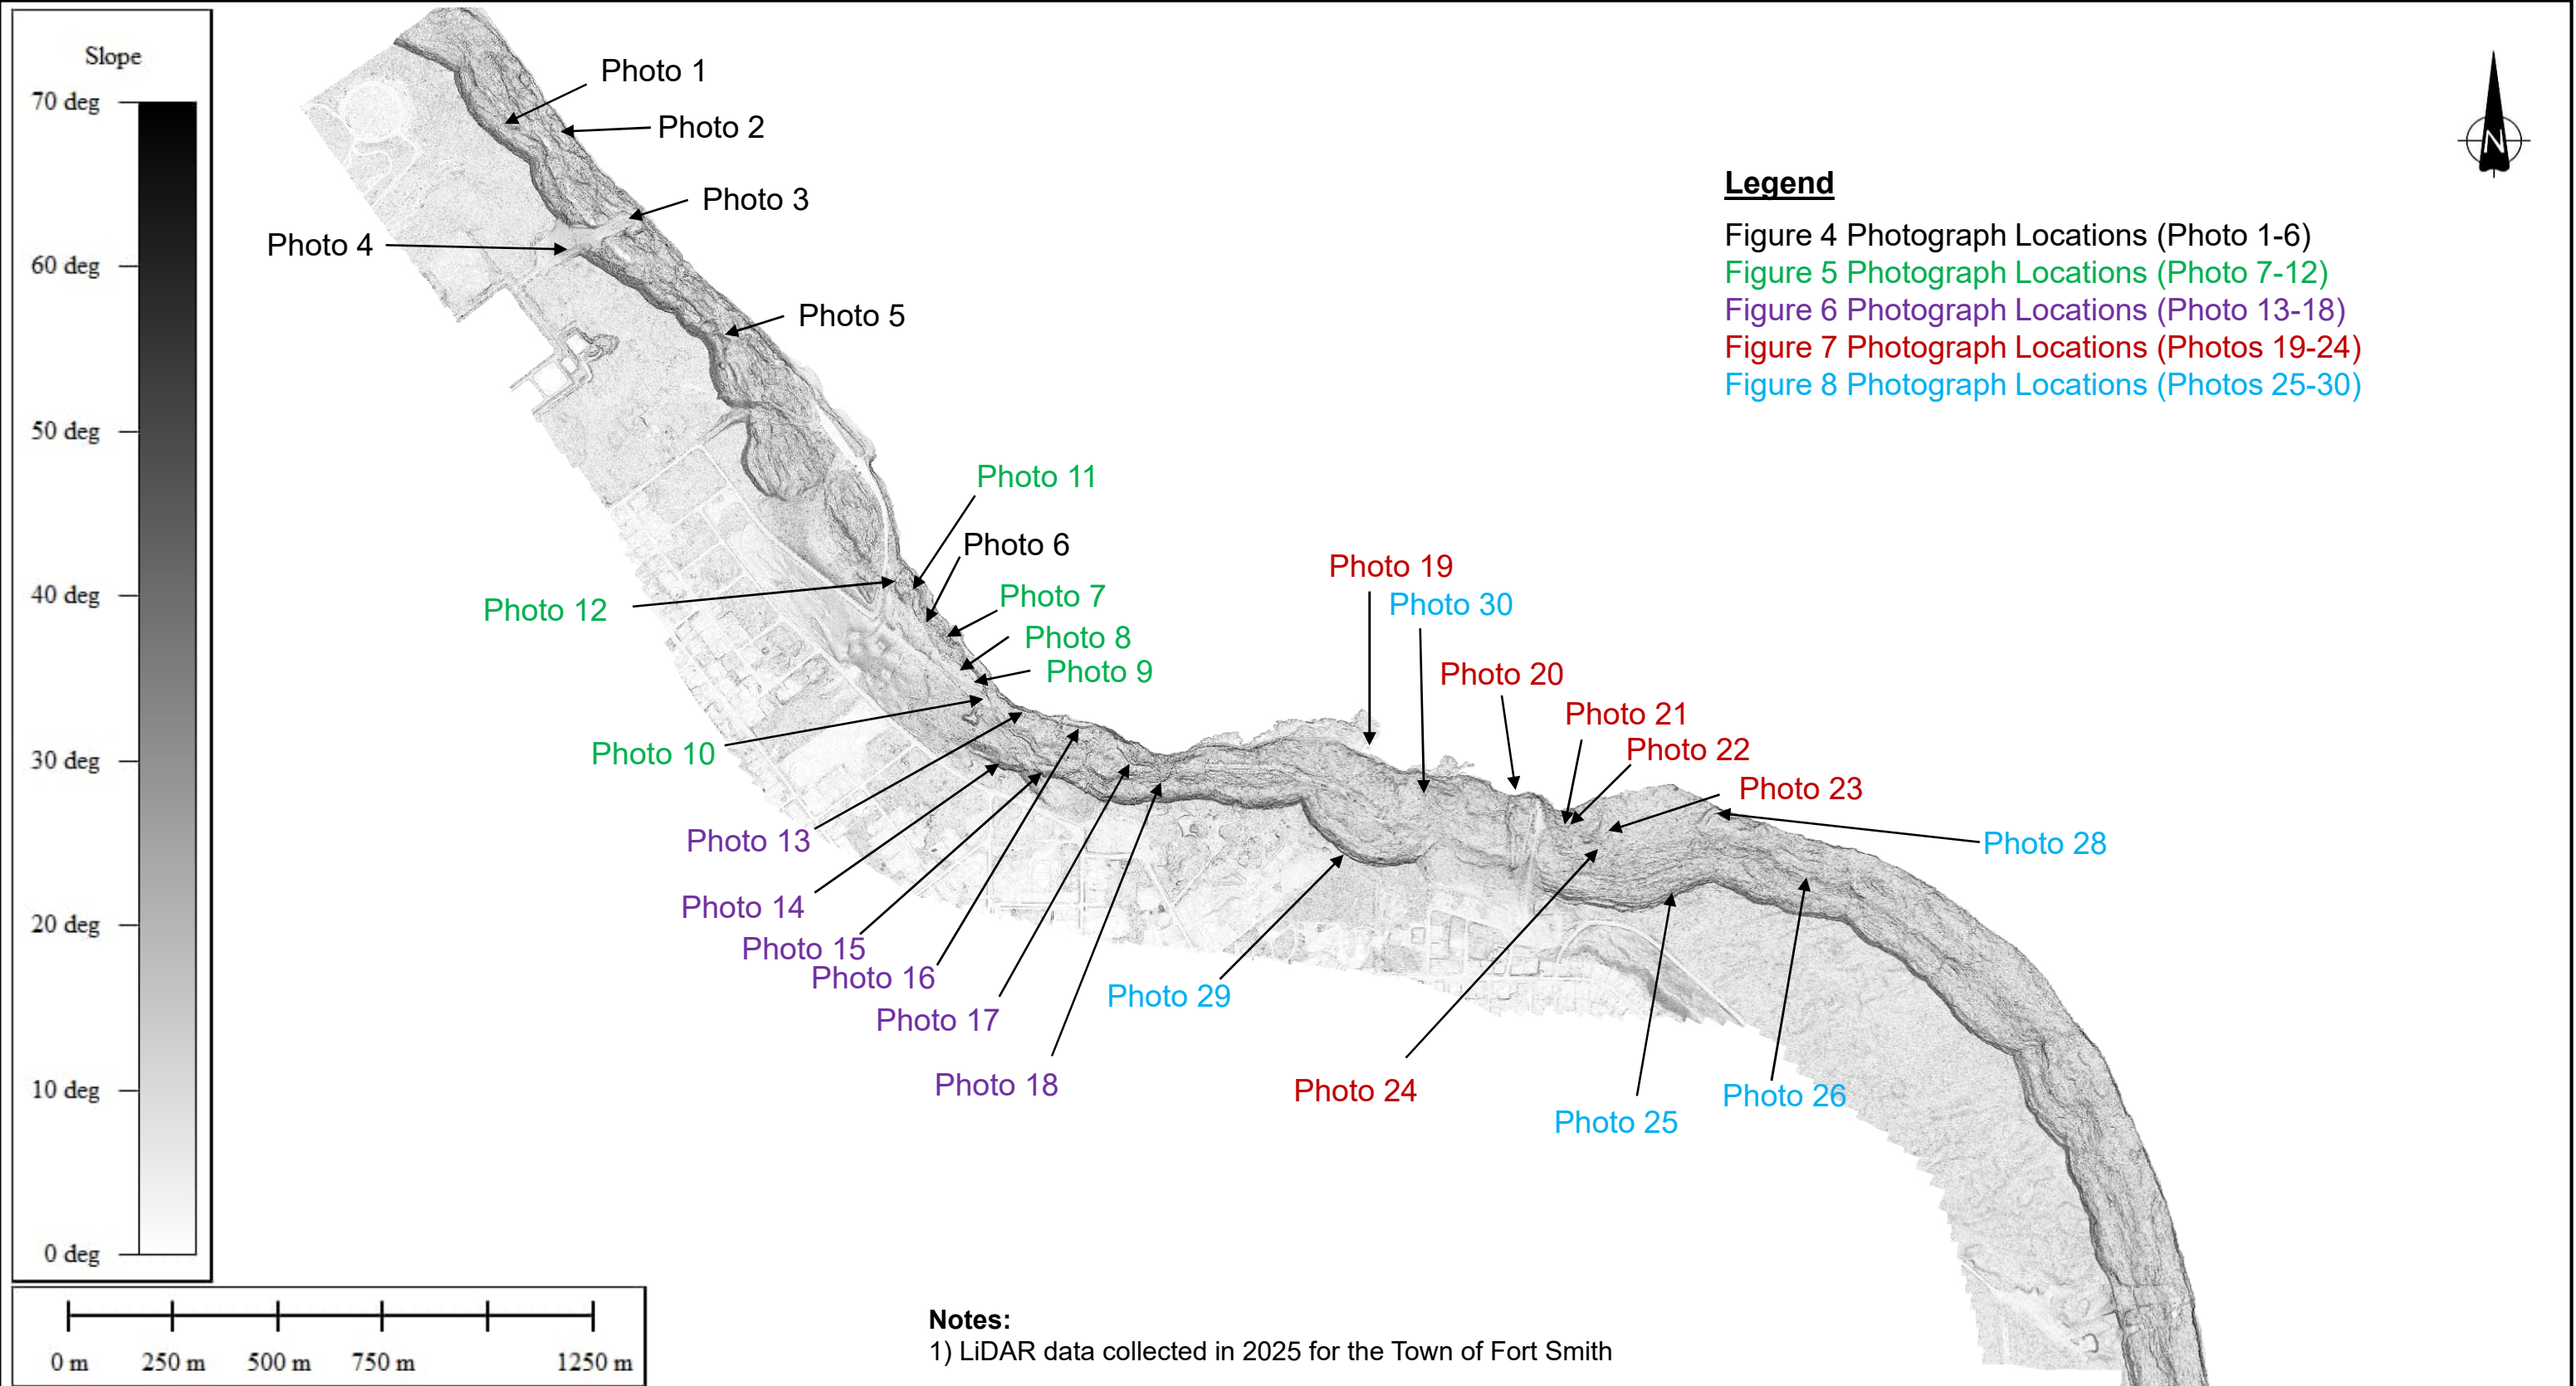
| Client:<br> | | Project Name:<br><b>Slope Monitoring Report 2025,<br/> Slave River Adjacent to Forth Smith NT</b><br><br>Figure Title:<br><b>2025 Visual Slope Inspection, Select Photographs</b> | Project Number:<br>CA0058096.7320<br><br>Figure Number:<br>3<br><br>Date:<br>March 2026 |

In general, the area with the most active landslide activity was observed between the boat launch access road and the cemetery, near the toe of the slope. These movements were not observed to be directly impacting known infrastructure, however the possibility of ongoing and future movements in these areas negatively impacting slope stability by extending further laterally or upslope cannot be ruled out.

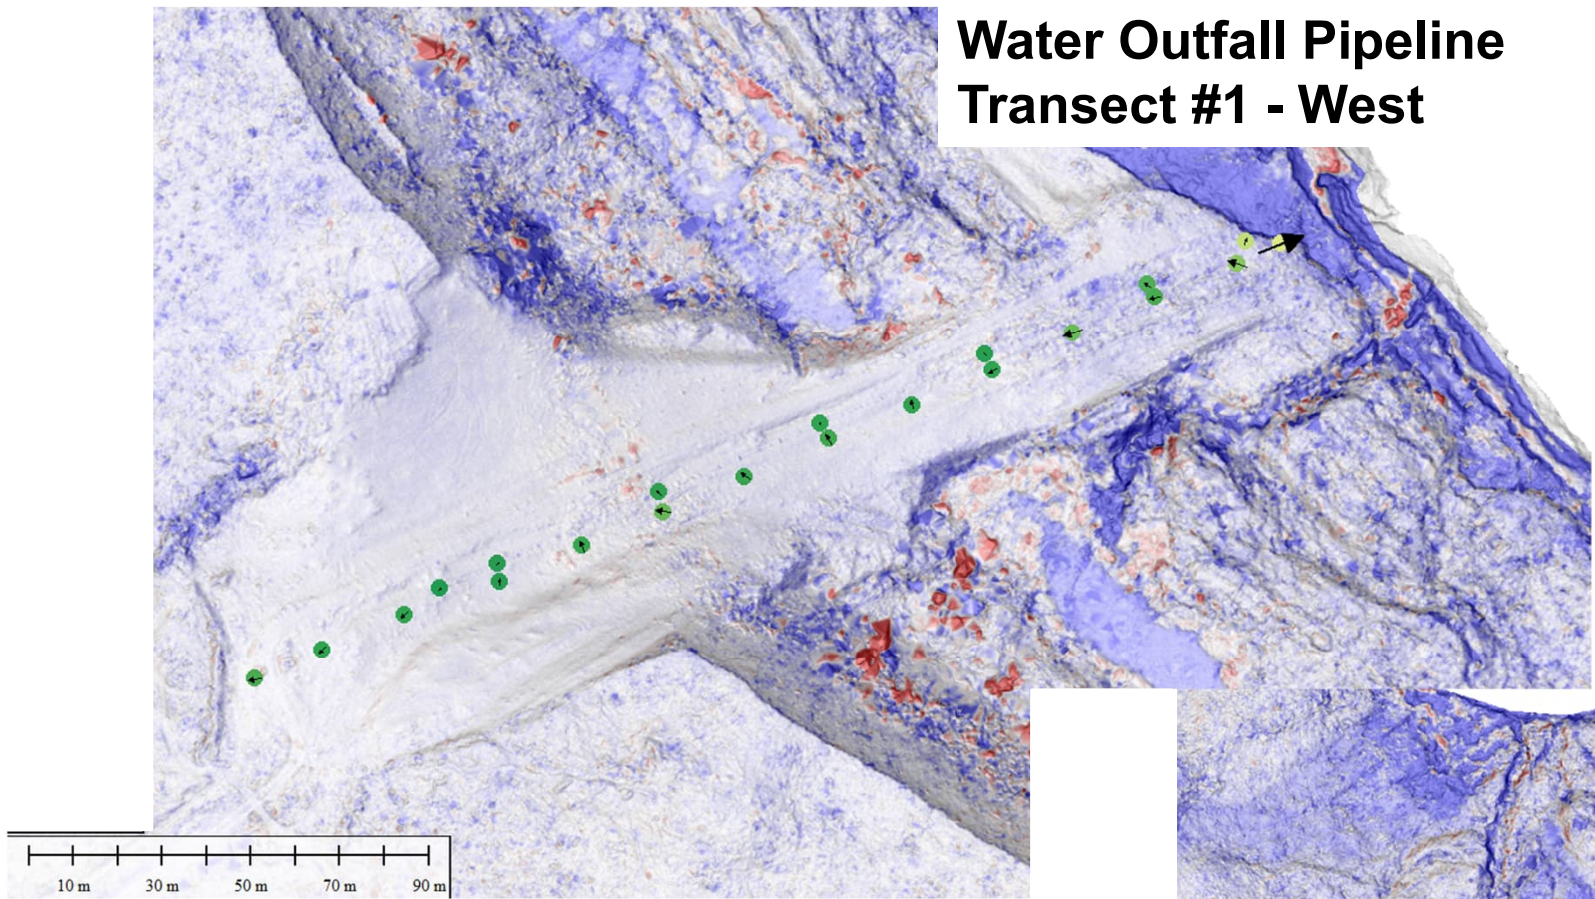
Water Outfall Pipeline  
Transect #1 - West

- Water Outfall Pipeline, Transect #1 – West: on this transect, the most measured vertical displacement was -158 mm and the most measured horizontal displacement was 142 mm, both for pin ID#4013. The horizontal displacement was in the downslope direction. This pin is near the toe of the slope, in the area where a large crack can be seen on the LiDAR (Figure 10) and is shown on Figure 4, Photo 3. All three pins in this area (ID#4012, 4013, 4014) indicate elevation displacement (drop) since the 2022 survey.

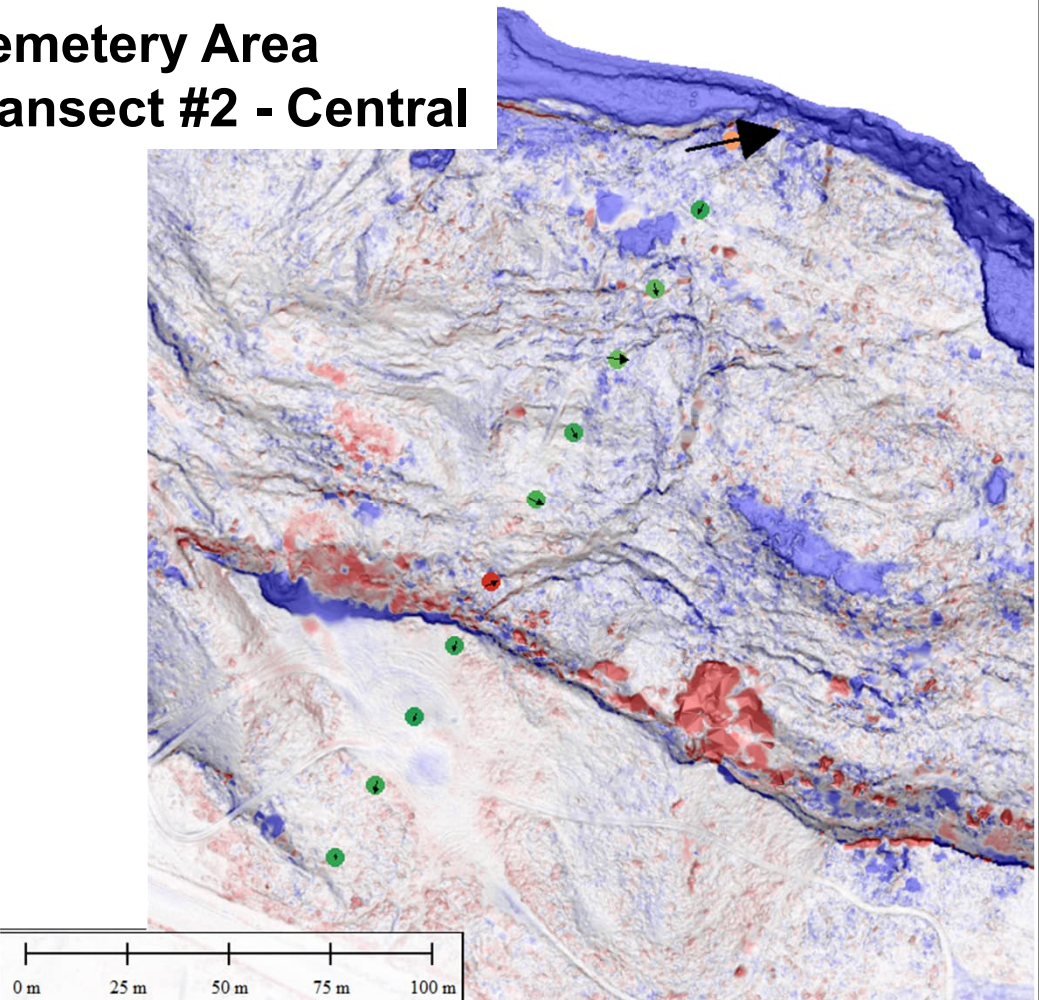
Cemetery Area  
Transect #2 - Central

- Cemetery Area, Transect #2 – Central: on this transect, the most vertical displacement is noted in pin ID#8004 (-396 mm), which is on the downslope side of the main headscarp (Figure 10 and Figure 6, Photo 15). There was also a minor horizontal component to movement, which was toward the toe of the slope. Elevation loss in this location makes sense with landslide mechanics for large deep seated movement. Pin ID#8010, near the toe of the slope, indicates the greatest elevation displacement (drop) of -396 mm, as well as lateral movement, approximately toward the river downslope. This area (Figure 10 and Figure 6, Photo 16) appears to be experiencing erosion near the edge of the river, and localized landsliding.
